Technical Service Bulletin (TSB)

Transmission Oil Cooler Line(s) Not Fully Seated Causing Potential Oil Leak

| REFERENCE: | TSB: 21-019-23 GROUP 21 - Transmission and Transfer Case | Date: | July 11, 2023 | REVISION: | - |
| VEHICLES AFFECTED: | 2023 (DT) RAM 1500 Pickup This bulletin applies to vehicles built on or after December 01, 2022 (MDH 1201XX) and on and before April 04, 2023 (MDH 0404XX) equipped with either: <ul style="list-style-type: none"> • 3.6L V6 24V VVT eTorque Engine Upgrade I (Sales Code ERG). • 6.2L Supercharged Hemi V8 SRT Engine (Sales Code ESD). | MARKET APPLICABILITY: | | | |

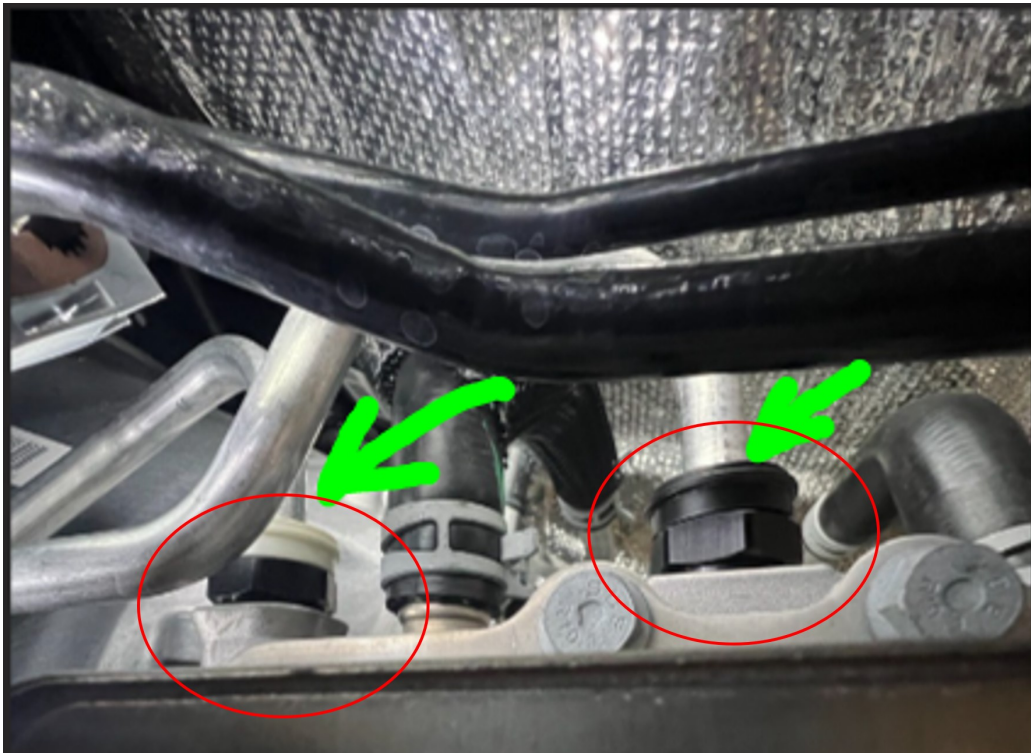
Fig. 1
Transmission Oil Cooler Lines Fully Seated

1. Fully seat the transmission oil cooler lines into the oil cooler and ensure the caps are fully seated into position (Fig. 1) .
2. Clean any residual fluid from under the vehicle.
3. Check and fill transmission fluid up to specifications.

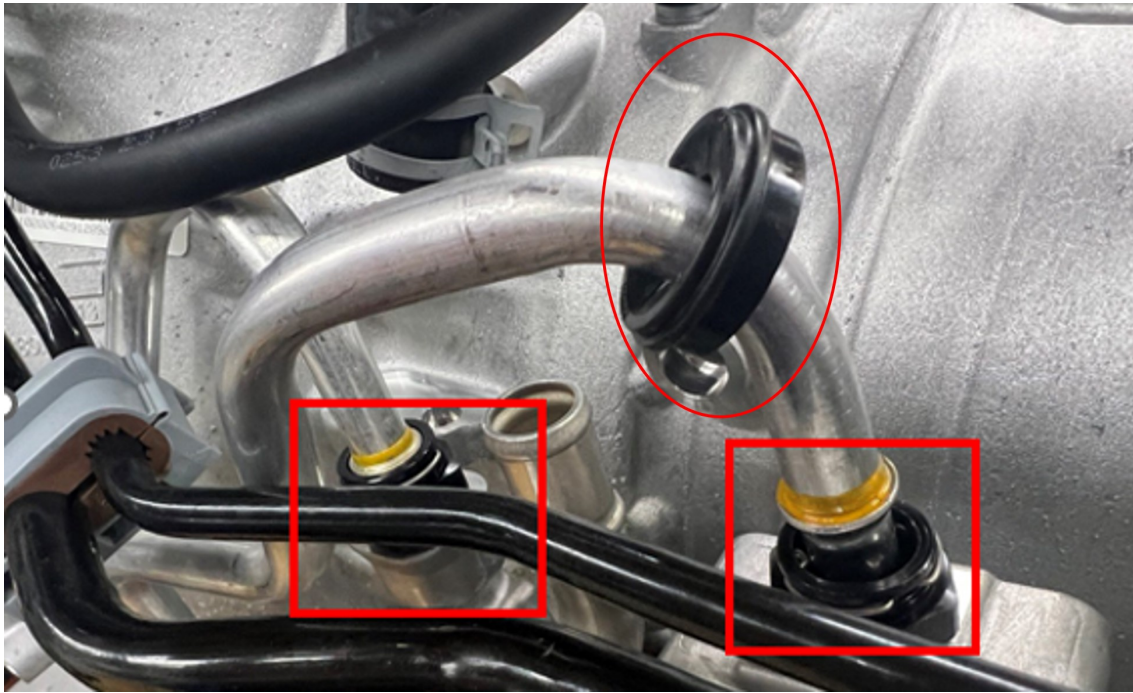
| CAUSE: | Transmission oil cooler lines not fully seated into transmission oil cooler. | | | | |

1. Is the vehicle on the RSU VIN list?
 - YES >>> Proceed to [Step 2](#).
 - NO>>> This Bulletin does not apply. Normal diagnosis should be performed.
2. Are the transmission oil cooler lines fully seated at the oil cooler?
 - YES >>> This bulletin has been completed, use inspect LOP (21-25-10-98) to close the active RSU ([Fig. 1](#)).
 - NO>>> The lines are not fully seated ([Fig. 2](#)), Proceed to [Step 1](#) of the Repair Procedure.

Fig. 2
Transmission Oil Cooler Lines NOT Fully Seated
