REFERENCE:	TSB: 08-162-23 GROUP 08 - Electrical	Date:	July 11, 2023	REVISION:	-
VEHICLES AFFECTED:	2022 - 2023 (DJ) RAM 2500 Pickup 2022 - 2023 (D2) RAM 3500 Pickup 2022 - 2023 (DD) RAM 3500 Cab Chassis 2022 - 2023 (DF) RAM 3500 10K LB. Cab Chassis 2022 - 2023 (DP) RAM 4500/5500 Cab Chassis This bulletin applies to vehicles built on and before May 20, 2023 (MDH 0520XX) equipped with a Global Telematics Box Module (Sales Code RDG).			MARKET APPLICABILITY:	
				<input checked="" type="checkbox"/> NA <input type="checkbox"/> SA <input type="checkbox"/> EE	<input type="checkbox"/> MEA <input type="checkbox"/> IAP <input type="checkbox"/> CH
CUSTOMER SYMPTOM:	The customer may experience the one or more of the following: <ul style="list-style-type: none"> • Uconnect Box Message at Startup. • Uconnect Box Error Or Requires Service Message. • Uconnect Mobile App trunk status showing as closed when trunk is open. • Diagnostic Trouble Codes (DTCs) for Electronic Control Modules (ECUs) won't be shown to customer through the Vehicle Health alert (Mobile App or email).

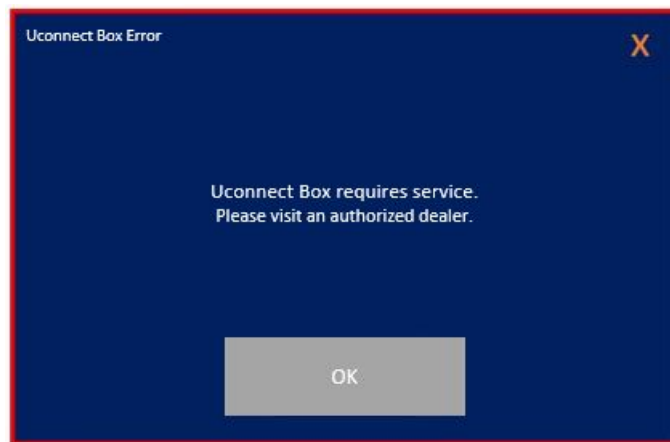
Fig. 1
Uconnect Box Error Message

CAUSE:	TBM Software

Message display on the radio screen, “Uconnect Box requires service. Please visit an authorized dealer.” (Fig. 1) , with no active or stored DTCs set by the TBM.

The TBM software will be updated from 5.25 to 5.39.1.

1. Reprogram the TBM with the latest software. Detailed instructions for flashing control modules using the wiTECH Diagnostic Application are available by selecting the application's "HELP" tab.
2. Clear all DTCs that may have been set in any module due to reprogramming. The wiTECH application will automatically present all DTCs after the flash and allow them to be cleared.
