Technical Service Bulletin (TSB)
Rear Cup Holders Warm

REFERENCE:	TSB: 23-011-23 REV. A GROUP 23 - Body	Date:	July 12, 2023	REVISION:	23-011-23
VEHICLES AFFECTED:	2021 -**2023** (WL) Grand Cherokee This bulletin applies to vehicles equipped with ATC W/4 Zone Temp Control (Sales Code HAL) and/or ATC W/3 Zone Temp Control (Sales Code HAH).	MARKET APPLICABILITY:			
		<input checked="" type="checkbox"/> NA		<input checked="" type="checkbox"/> CH	
		<input checked="" type="checkbox"/> EE		<input checked="" type="checkbox"/> IAP	
		<input checked="" type="checkbox"/> SA		<input checked="" type="checkbox"/> MEA	
CUSTOMER SYMPTOM:	Customers may comment on the following: <ul style="list-style-type: none"> When the rear heat temperature is set at or near max hot output, the front center console's surfaces, first row and second row cup holders and storage bins are getting warm to the touch. 				
CAUSE:	Missing center console insulator.

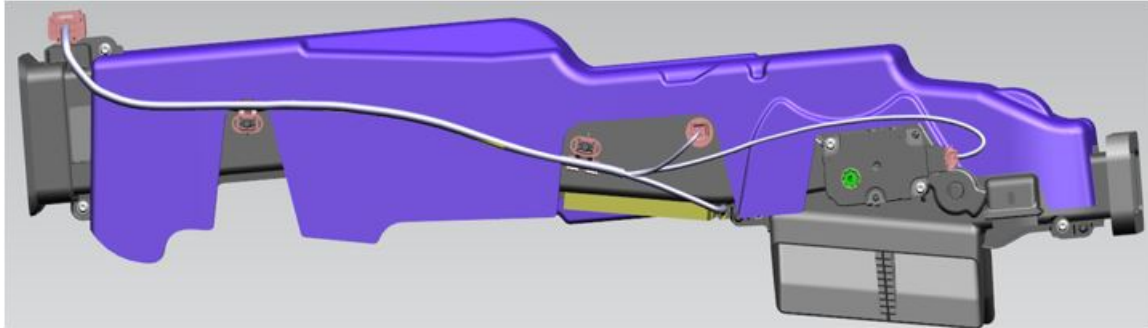
Fig. 1
Passenger's Side

NOTE: When installing the cover make sure not to cover the wire harness on the floor duct. The photos below show the covers already installed (purple in color) (Fig. 1) , (Fig. 2) and (Fig. 3) .

This bulletin involves removing the front center console and installing an insulator foam pad on top of the Center Console air duct.

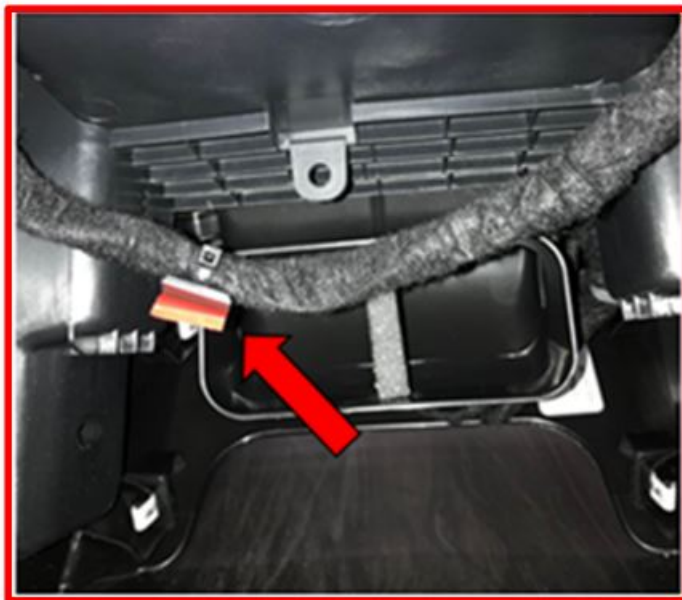
2. Check if there is a wire harness retainer is properly attached to the underside of the console (Fig. 4) .

Fig. 4
Retainer Clip Not Attached

3. If retainer clip is not attached, peel off paper from adhesive and stick retainer clip to the underside of the console (Fig. 5) .

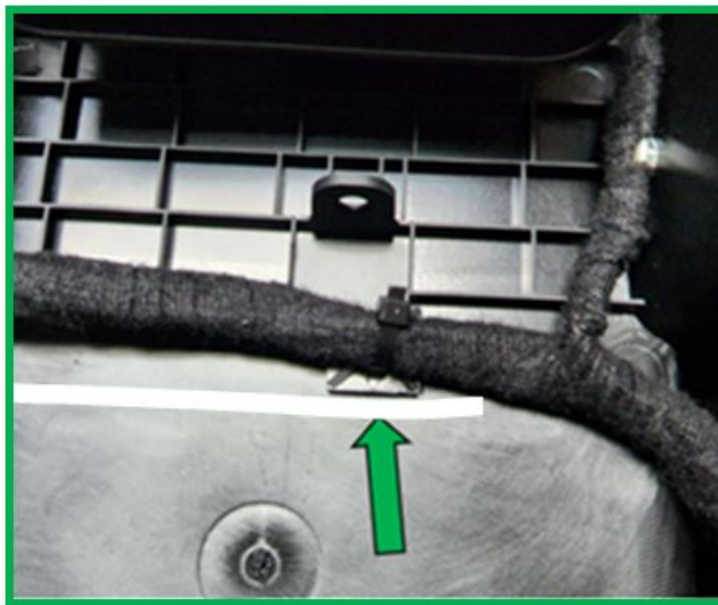
Fig. 5
Retainer Clip Properly Attached
