REFERENCE:	TSB: 23-083-23 GROUP 23 - Body	Date:	July 12, 2023	REVISION:	-
VEHICLES AFFECTED:	2018 - 2023 (JL) Jeep Wrangler 2020 - 2023 (JT) Jeep Gladiator This bulletin applies to vehicles built on or before June 02, 2023 (MDH 0602XX).	MARKET APPLICABILITY:			
		<input checked="" type="checkbox"/> NA		<input checked="" type="checkbox"/> MEA	
		<input type="checkbox"/> SA		<input type="checkbox"/> IAP	
		<input type="checkbox"/> EE		<input type="checkbox"/> CH	
CUSTOMER SYMPTOM:	One or both sunvisors rocking or are loose.				
CAUSE:	Missing foam pads.

This bulletin involves adding foam pads to both sunvisor body mounts.

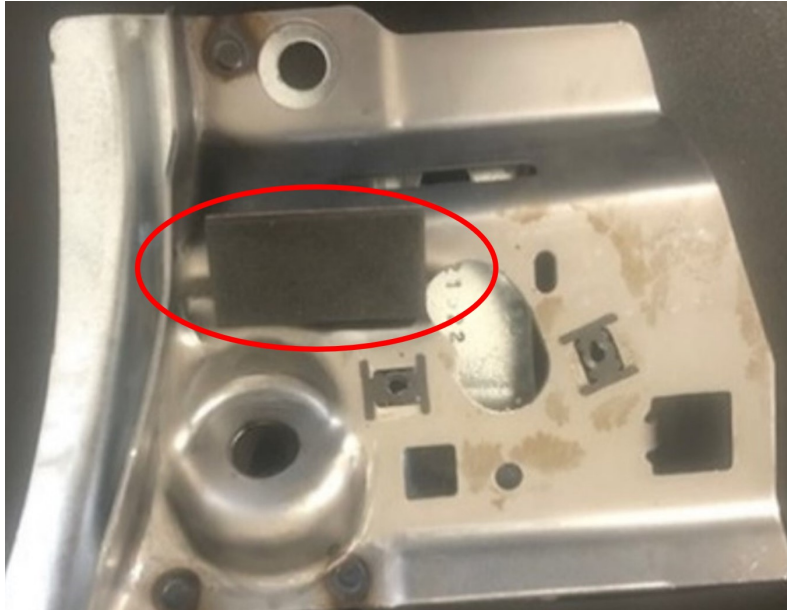
Fig. 1

Foam Pad To The Left Side Sunvisor Body Mount Location

2. Peel and stick the foam pad to the sunvisor body mount (Fig. 1) . Ensure it is aligned horizontally with the front of the vehicle (Fig. 2) .

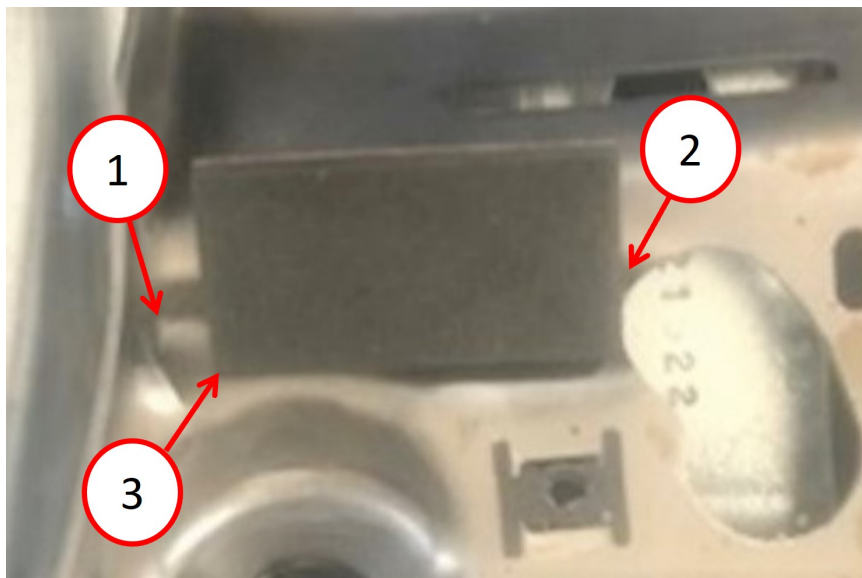
Fig. 2

Foam Pad To The Sunvisor Body Mount Alignment Points

- 1 - Align Edge Of Foam To The Hole In Body LH/RH
- 2 - Align Edge Of Foam To The Channel Form In The Body LH/RH
- 3 - Horizontally Placed Foam Pad - Left Side
