| REFERENCE: | TSB: 08-164-23<br>GROUP 08 - Electrical | Date: | July 12, 2023 | REVISION: | – |
| VEHICLES AFFECTED: | 2017 - 2018 (GA) Alfa Romeo Giulia<br>This bulletin applies to vehicles built on or before July 12, 2018 (MDH 0712XX) equipped with a 2.0L I4 DI Turbo Engine (Sales Code EC2). | | | MARKET APPLICABILITY:<br><input checked="" type="checkbox"/> NA <input type="checkbox"/> MEA<br><input type="checkbox"/> SA <input type="checkbox"/> IAP<br><input checked="" type="checkbox"/> EE <input type="checkbox"/> CH | |
| CAUSE: | Additional humidity sensor harness needed. | | | | |

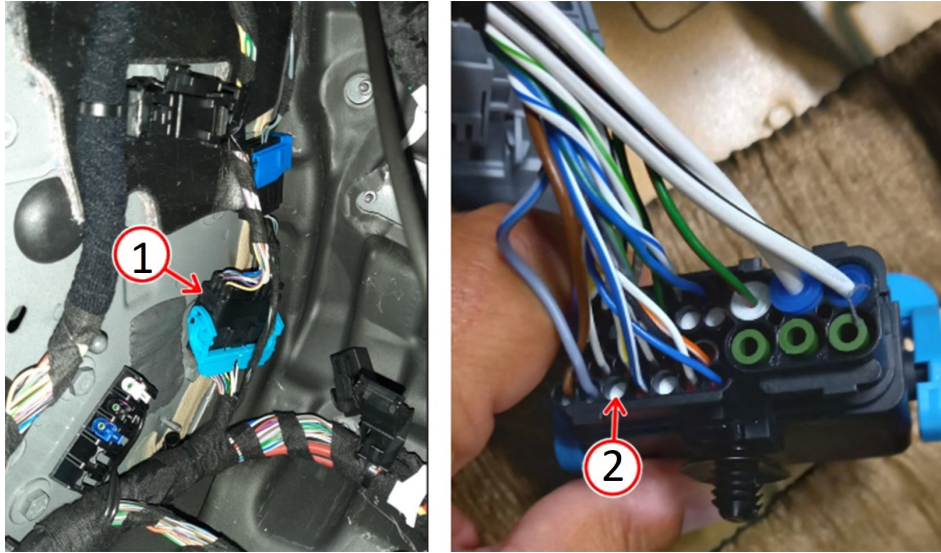
Fig. 2  
3-way Connector

**NOTE: Pin 30 of connector not is connected.**

- 1 - 32-way Junction Harness.  
2 - Pin 30.
-

2. Locate the 32-way junction between the rear and vehicle wiring harness under the dashboard on the left side, recognizable by the blue lever (Fig. 2) .
3. Locate pin 30 on the vehicle wiring side connector to which the new (Mopar #50575355) harness is to be connected (Fig. 2) .

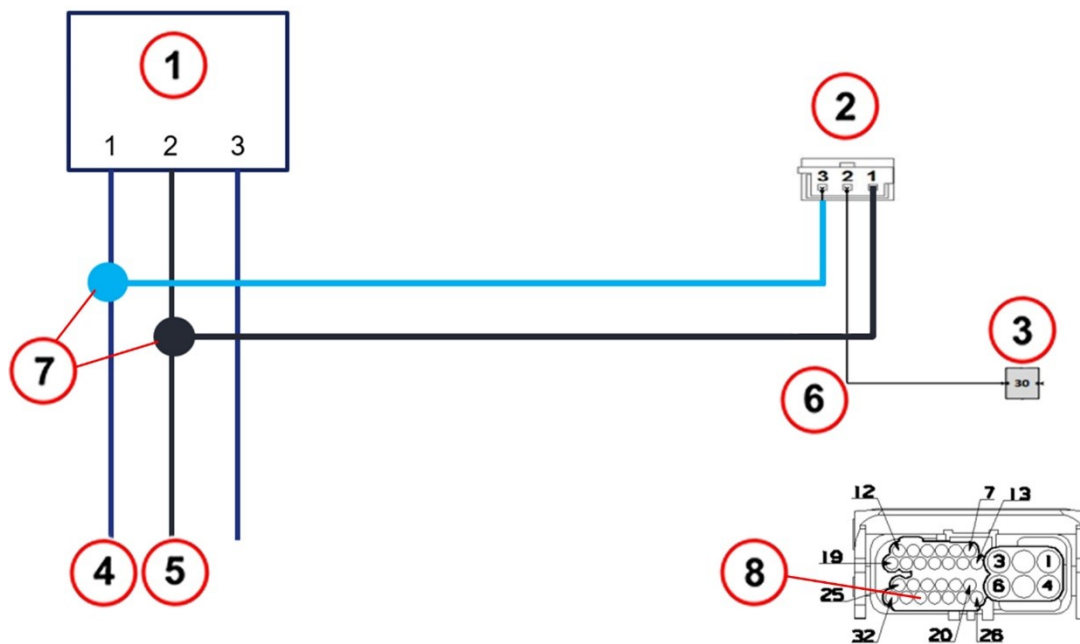
Fig. 3  
32-way Junction

- 1 - Rain And Dusk Sensor.
- 2 - Connectors Sensor Signal.
- 3 - 32-way Junction Between Rear And Front Wiring Harnesses.
- 4 - Blue/Red Cable.
- 5 - Black Cable.
- 6 - Grey-Black Cable.
- 7 - New Junction.
- 8 - Pin 30 on 32-way Connector (Front Wiring Side).

4. On the 3-way connector cables of the rain sensor/dusk sensor, make two junctions according to the cable colors in the diagram (Fig. 3) .
5. Route the grey-black cable from pin 2 of the humidity sensor parallel to the cable on the vehicle (windscreen area, front left pillar, under the dashboard) (Fig. 3) .
6. Disconnect the 32-way junction located under the dashboard on the left side (Fig. 3) .
7. Remove the white plug from pin 30 of the vehicle wiring harness side connector (Fig. 3) .
8. Insert the terminal from the black-grey jumper into pin 30 and reconnect the 32-way junction (Fig. 3) .
