REFERENCE:	TSB: 08-165-23 GROUP 08 - Electrical	Date:	July 13, 2023	REVISION:	-
VEHICLES AFFECTED:	2022 (MP) Jeep Compass This bulletin applies to vehicles equipped with a 360 Surround View Camera System (Sales Code XAK).			MARKET APPLICABILITY: <input checked="" type="checkbox"/> NA <input type="checkbox"/> MEA <input type="checkbox"/> SA <input checked="" type="checkbox"/> IAP <input type="checkbox"/> EE <input type="checkbox"/> CH	
CUSTOMER SYMPTOM:	The customer may describe the following: <ul style="list-style-type: none"> Radio screen flickers in blue whenever the 360 camera is activated and brake pedal pressed. 				
CAUSE:	Electromagnetic interference between the coax cable and power feed circuits within the Instrument Panel (IP) harness.

This bulletin involves installing a coax cable jumper harness.

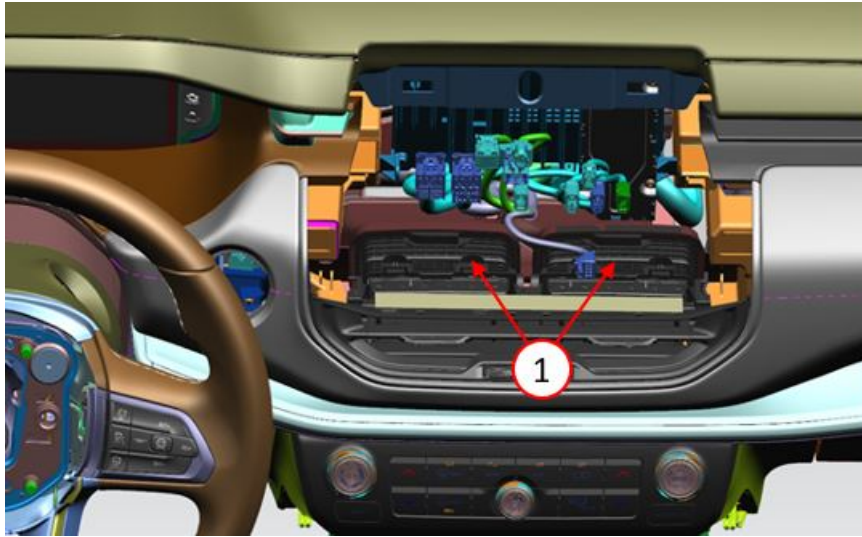
Fig. 1
Air Duct Location

1 - Air Ducts

1. Remove the radio display screen. Refer to the detailed service procedures available in DealerCONNECT> Service Library under: Service Info> 23 - Body / Instrument Panel / Bezel, Instrument Panel, Center / Removal.
2. Remove the air ducts that are located behind the display screen (Fig. 1) .

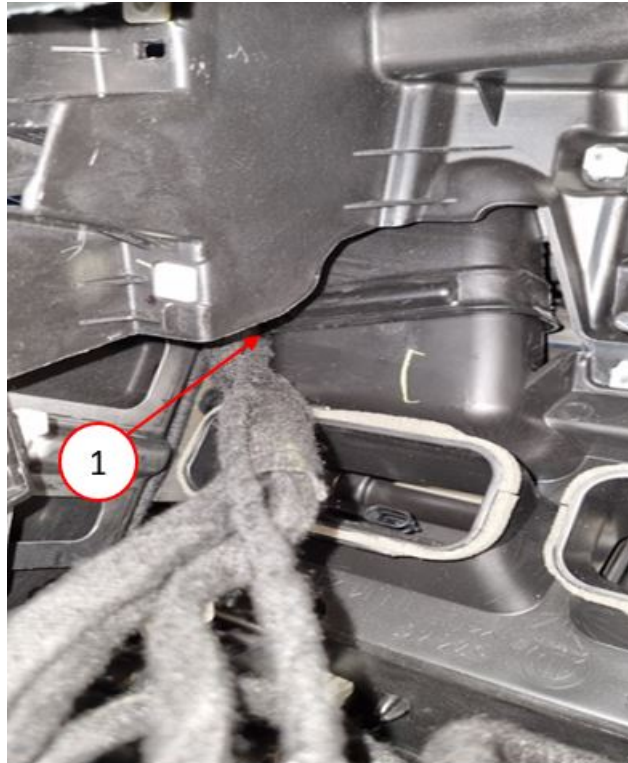
Fig. 4
Jumper Harness Pass Through

1 - Run Jumper Harness Through This Opening

6. Tape the original pink and red coax connectors to the main harness.
7. Connector D2784N (red) to the radio and run the new jumper harness (P/N 68632387AA) through the hole on the left side of the Instrument Panel (IP) next to the main harness (Fig. 4) .

NOTE: Make sure this jumper is loose and not trapped with any other component. The jumper must not be taut and/or in hard contact with sharp edges.
