| REFERENCE: | TSB: 08-173-23<br>GROUP 08 - Electrical | Date: | July 13, 2023 | REVISION: | — |
| VEHICLES AFFECTED: | 2022 - 2023 (VF) RAM ProMaster<br>This bulletin applies to vehicles built on and before January 09, 2023 (MDH 0109XX) equipped with one of the following radios: <ul style="list-style-type: none"><li>Uconnect 5 W 7" Display (Sales Codes UBC or UEC).</li></ul> | | | MARKET APPLICABILITY:<br><input checked="" type="checkbox"/> NA<br><input type="checkbox"/> SA<br><input type="checkbox"/> EE<br><input type="checkbox"/> MEA<br><input type="checkbox"/> IAP<br><input type="checkbox"/> CH | |

| <b>CAUSE:</b> | Radio software |

This bulletin involves inspecting the software level and updating the software from 139.01.19 or 139.01.60 to 145.00.15.

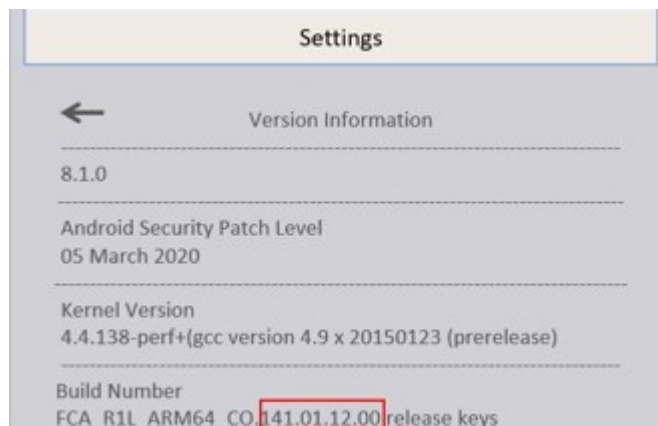
**Fig. 1**  
**Radio Software Level Screen**

1. On the radio display screen go into “Vehicle Settings”.
2. Select “System Information”.
3. Select “Version Information”.
4. Under the “Build Number”, radio software version is listed (Fig. 1) .

5. Is the software compatible for the update?
  - YES>>> The software version is below 145.00.15. Proceed to [Step 1](#) of the repair procedure below.
  - NO>>> If the software version is at or above 145.00.15, the radio is already at updated software. This bulletin has been completed, Use inspection LOP (18-60-03-AS) to close the active RSU.
