**Technical Service Bulletin (TSB)**  
**Front Control Arm Bushings Noise**

<b>REFERENCE:</b>	<b>TSB:</b> 02-005-23 <b>GROUP</b> 02 - Front Suspension	<b>Date:</b>	July 15, 2023	<b>REVISION:</b>	-
<b>VEHICLES AFFECTED:</b>	2023 (LA) Dodge Challenger 2023 (LD) Dodge Charger 2023 (LX) Chrysler 300 This bulletin applies to vehicles built on and after February 08, 2023 (MDH 0208XX) and on and before February 09, 2023 (MDH 0209XX).	<b>MARKET APPLICABILITY:</b>			
<b>CUSTOMER SYMPTOM:</b>	The technician or customer may notice the following: <ul style="list-style-type: none"> <li>Knock or rattle noise when going over bumps.</li> </ul>				
<b>CAUSE:</b>	Front lower control arm bushings under cured.

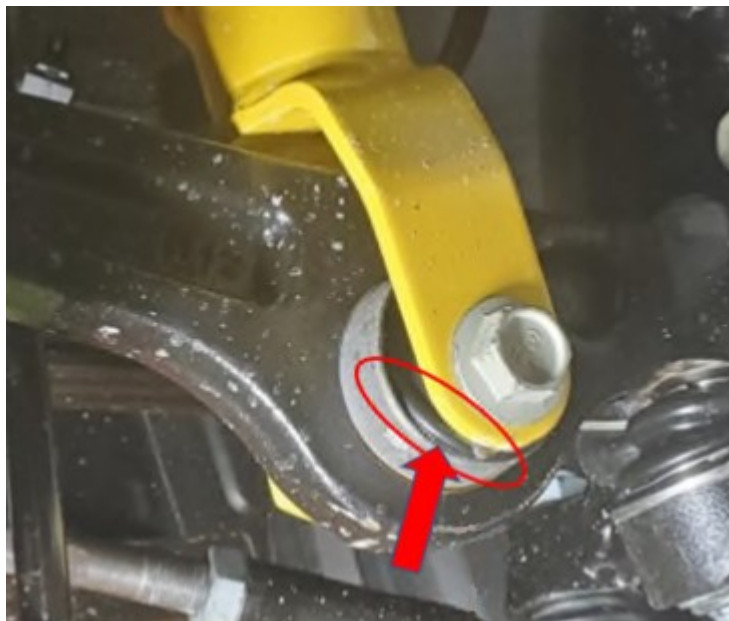
1. Pull vehicle onto flat, dry surface (suspension should remain loaded).
2. Bushing is bad if there is rubber bulging out from the bottom area of the bushing (Fig. 1) .

**Fig. 1**  
**Bad Bushing**

**NOTE: Only replace the one (or both) side control arm that the bushings are bulged out / bad on.**

1. Replace lower control arm(s). Refer to the detailed service procedures listed in DealerCONNECT Service Library under: 02 - Front Suspension / Front / Arm, Lower Control / Removal and installation.
2. Perform Alignment. Refer to the detailed service procedures listed in DealerCONNECT Service Library under: 02 - Front Suspension / Wheel Alignment / Standard Procedure.
