REFERENCE:	TSB: 08-175-23 GROUP 08 - Electrical	Date:	July 15, 2023	REVISION:	—
VEHICLES AFFECTED:	2021 - 2023 (RU) Chrysler Pacifica This bulletin applies to vehicles built on and before June 04, 2023 (MDH 0604XX) equipped with the following: Global Telematics Box Module (Sales Code RDG).		MARKET APPLICABILITY: <input checked="" type="checkbox"/> NA <input type="checkbox"/> MEA <input type="checkbox"/> SA <input type="checkbox"/> IAP <input type="checkbox"/> EE <input type="checkbox"/> CH		
CUSTOMER SYMPTOM:	<p>Customers may experience one or more of the following:</p> <ul style="list-style-type: none"> • Uconnect box requires service message (Fig. 1) . • Uconnect box backup “battery low” message on the radio. • WiFi hotspot streaming lost. • Rear mirror LED blinking after ignition cycle. • Uconnect App charge schedule / climate schedule setup issue. • Customer not seeing profile or other vehicle information on the mobile app.

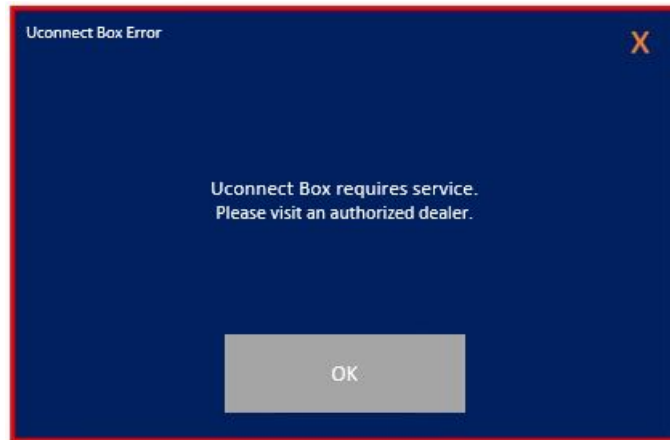
CAUSE:	TBM Software

Fig. 1
Uconnect Box Error Message

Message display on the radio screen, “Uconnect Box requires service. Please visit an authorized dealer.” (Fig. 1) , with no active or stored Diagnostic Trouble Codes (DTCs) set by the TBM.

This bulletin involves updating the TBM software from 4.29d to 4.36.

1. Reprogram the TBM 2.0 with the latest software 4.36. Detailed instructions for flashing control modules using the wiTECH Diagnostic Application are available by selecting the application's "HELP" tab.
2. Clear all DTCs that may have been set in any module due to reprogramming. The wiTECH application will automatically present all DTCs after the flash and allow them to be cleared.
