REFERENCE:	TSB: 08-139-23 REV. A GROUP 08 - Electrical	Date:	July 18, 2023	REVISION:	08-139-23
VEHICLES AFFECTED:	2023 (DJ) RAM 2500 Pickup 2023 (D2) RAM 3500 Pickup 2023 (DD) RAM 3500 Cab Chassis 2023 (DF) RAM 3500 10K LB. Cab Chassis 2023 (DP) RAM 4500/5500 Cab Chassis This bulletin applies to vehicles built on and before May 20, 2023 (MDH 0520XX) equipped with a Global Telematics Box Module (Sales Code RDG).			MARKET APPLICABILITY:	
				<input checked="" type="checkbox"/> NA	<input type="checkbox"/> MEA
				<input type="checkbox"/> SA	<input type="checkbox"/> IAP
				<input type="checkbox"/> EE	<input type="checkbox"/> CH
CUSTOMER SYMPTOM:	Customers may experience one or more of the following: <ul style="list-style-type: none"> • Uconnect Box Message at startup. • Uconnect Box Error or Requires Service Message. • Connectivity: Diagnostic Trouble Codes (DTCs) for Electronic Control Modules (ECUs) won't be shown to customer through the Vehicle Health alert (Mobile app or email).

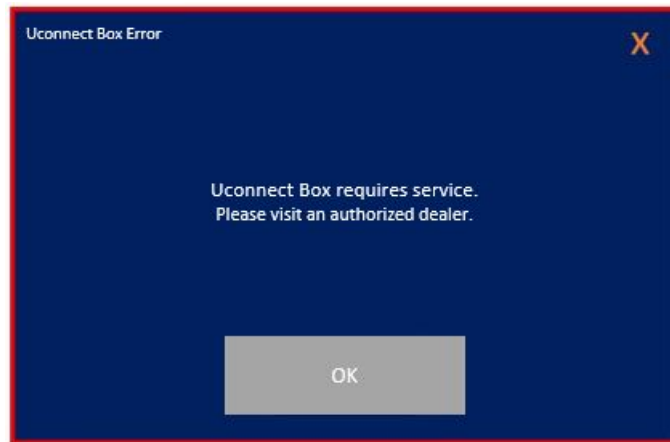
Fig. 1
Uconnect Box Error Message

CAUSE:	TBM software.

Message display on the radio screen, “Uconnect Box requires service. Please visit an authorized dealer.” (Fig. 1) , with no active or stored DTCs set by the TBM.

This bulletin provides information regarding the latest Firmware Over The Air (FOTA) update and provides the service technician an overview of the steps a customer will need to take to complete the update. The TBM software will be updated from **5.13 and** 5.25 to 5.39.1.
