REFERENCE:	TSB: 08-177-23 GROUP 08 - Electrical	Date:	July 19, 2023	REVISION:	-
VEHICLES AFFECTED:	2022 – 2023 (DT) RAM 1500 Pickup This bulletin applies to vehicles equipped with a Global Telematics Box Module (Sales Code RDG).	MARKET APPLICABILITY:			
		<input checked="" type="checkbox"/> NA		<input type="checkbox"/> MEA	
		<input type="checkbox"/> SA		<input type="checkbox"/> IAP	
		<input type="checkbox"/> EE		<input type="checkbox"/> CH	
CUSTOMER SYMPTOM:	<p>The customer may experience the one or more of the following:</p> <ul style="list-style-type: none"> • Uconnect Box Message at Startup. • Uconnect Box Error Or Requires Service Message. • Diagnostic Trouble Codes (DTCs) for Electronic Control Modules (ECUs) won't be shown to customer through the Vehicle Health alert (Mobile App or email). 				
CAUSE:	TBM Software

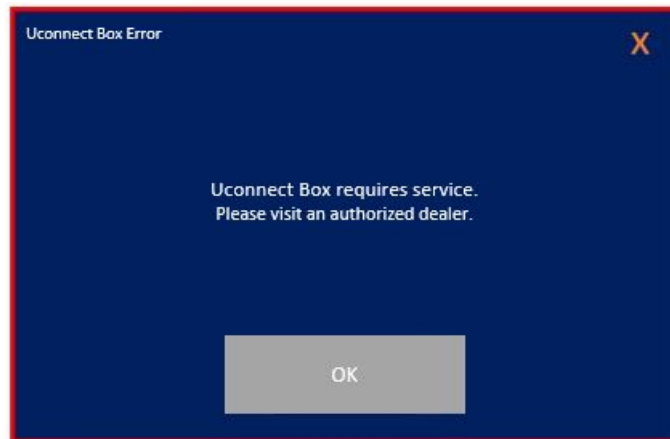
Fig. 1
Uconnect Box Error Message

Message display on the radio screen, “Uconnect Box requires service. Please visit an authorized dealer.” (Fig. 1) , with no active or stored DTCs set by the TBM.

This bulletin involves reprogramming the TBM with the latest available software.

1. Reprogram the TBM with the latest software. Detailed instructions for flashing control modules using the wiTECH Diagnostic Application are available by selecting the application's "HELP" tab.
2. Clear all DTCs that may have been set in any module due to reprogramming. The wiTECH application will automatically present all DTCs after the flash and allow them to be cleared.
