<b>REFERENCE:</b>	<b>TSB:</b> 23-081-23 REV. A <b>GROUP</b> 23 - Body	<b>Date:</b>	July 20, 2023	<b>REVISION:</b>	23-081-23
<b>VEHICLES AFFECTED:</b>	<b>2023 (WS) Grand Wagoneer/Wagoneer</b> This bulletin applies to vehicles built on or after January 09, 2023 (MDH 0109XX) and on or before April 04, 2023 (MDH 0404XX) equipped with Sea Salt/Black (Sales Code D7) or Global Black (Sales Code X7).	<b>MARKET APPLICABILITY:</b>			
<b>CUSTOMER SYMPTOM:</b>	Mismatched front seat covers (one or more seat covers have a "SERIES 1" badge (Fig. 1) , others have no badges). 2023 (WS) Grand Wagoneer/Wagoneer front seat covers do not have badges.				
<b>CAUSE:</b>	Model Year 2022 front seat covers installed.

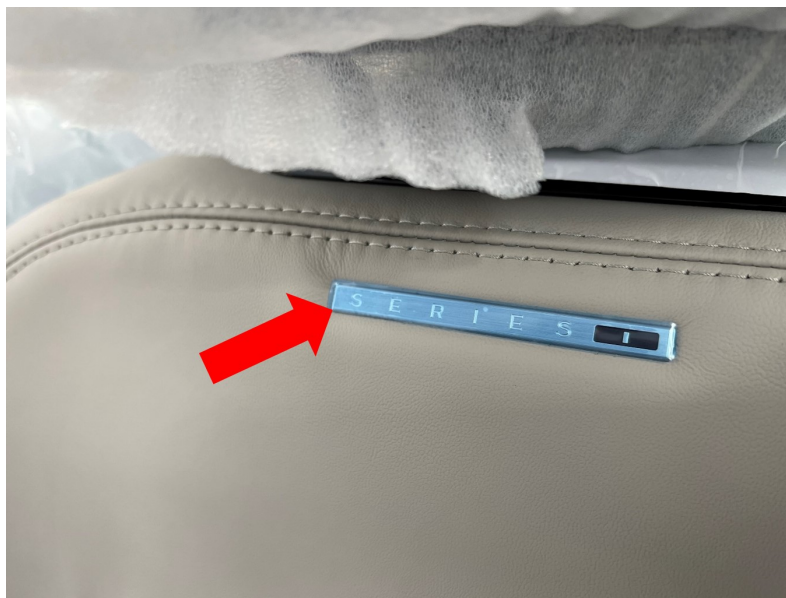
**Fig. 1**  
**Incorrect "SERIES 1" Badge Front Seat Cover**

1. Replace the front seat covers as required. Refer to the detailed service procedures available in DealerCONNECT/Service Library under: Service Info>23 - Body / Seats, Front / Cover, Seat Back, Front / Removal and Installation.
