## Technical Service Bulletin (TSB)

### Lower Radiator Hose not Properly Seated

| REFERENCE: | TSB: 09-015-23<br>GROUP 09 - Engine | Date: | July 22, 2023 | REVISION: | – |
| VEHICLES AFFECTED: | 2023 (JT) Jeep Gladiator<br>This bulletin applies to the following vehicles built on or after June 11, 2023 (MDH 0611XX) on or before June 14, 2022 (MDH 0614XX) equipped with a 3.6L V6 VVT Engine Upgrade 1 (Sales Code ERC). | | | MARKET APPLICABILITY:<br><input checked="" type="checkbox"/> NA<br><input type="checkbox"/> SA<br><input type="checkbox"/> EE<br><input type="checkbox"/> MEA<br><input type="checkbox"/> IAP<br><input type="checkbox"/> CH | |

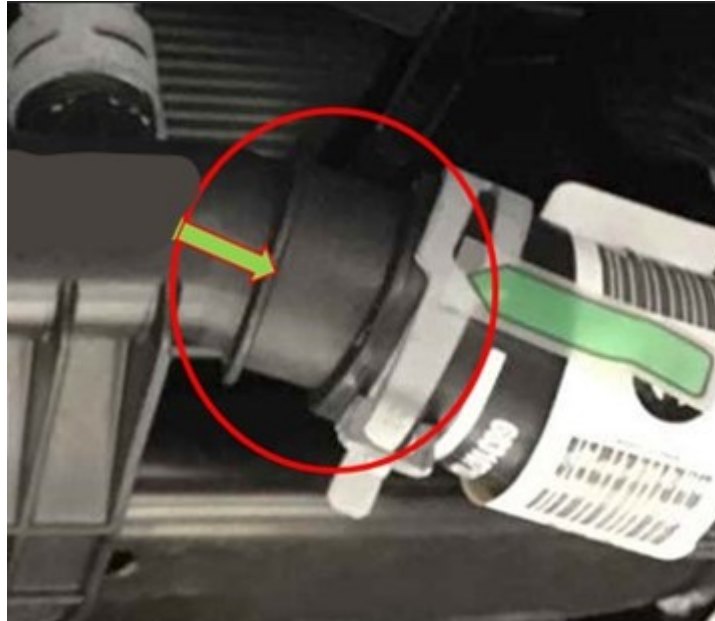
**Fig. 1**

| CAUSE: | Lower radiator hose is not seated properly. | | | | |

**NOTE:** The radiator hose should be fully seated against the plastic stop (Fig. 1) on the engine.

**Lower Radiator Hose Not Fully Seated Against Plastic Stop**

1. Compress the radiator hose clamp and push the lower hose to the fully seated position against the plastic stop (Fig. 1) .
2. Release the radiator hose clamp at the lower radiator hose.
3. Lower the vehicle.
4. Check and top off the coolant.
5. Run the engine and check for leaks.
