REFERENCE:	TSB: 08-082-23 REV. A GROUP 08 - Electrical	Date:	July 25, 2023	REVISION:	08-082-23
VEHICLES AFFECTED:	<p>2022 - **2023** (DS) RAM 1500 Pickup 2022 (DT) RAM 1500 Pickup 2022 (DJ) RAM 2500 Pickup 2022 (DD) RAM 3500 Cab Chassis 2022 (D2) RAM 3500 Pickup 2022 (DP) RAM 4500/5500 Cab Chassis 2022 (DF) RAM <10K Cab Chassis 2022 (RU) Chrysler Pacifica</p> <p>This bulletin applies to vehicles equipped with one of the following radios:</p> <ul style="list-style-type: none"> • Uconnect 5 w 7" Display (Sales Code UBC UEC). • Uconnect 5 W 8.4" Display (Sales Codes UFD, UPD UBD and UED). <p>**This bulletin applies to DS vehicles built on or before April 15, 2023 (MDH 0415XX).**</p>			MARKET APPLICABILITY:	
CUSTOMER SYMPTOM:	<p>The customer may describe one or more of the following:</p> <ul style="list-style-type: none"> • **Media source changes to AM after the theme mode is changed (ex. headlights on - dark mode). • Audio cuts out at volume levels 30 or above. • System switches to Wireless after key cycle, profile change, or theme mode change. • Wireless phone interface freezes after user accepts incoming call when in a conference call. • Wi-Fi Hotspot gets disabled automatically whe

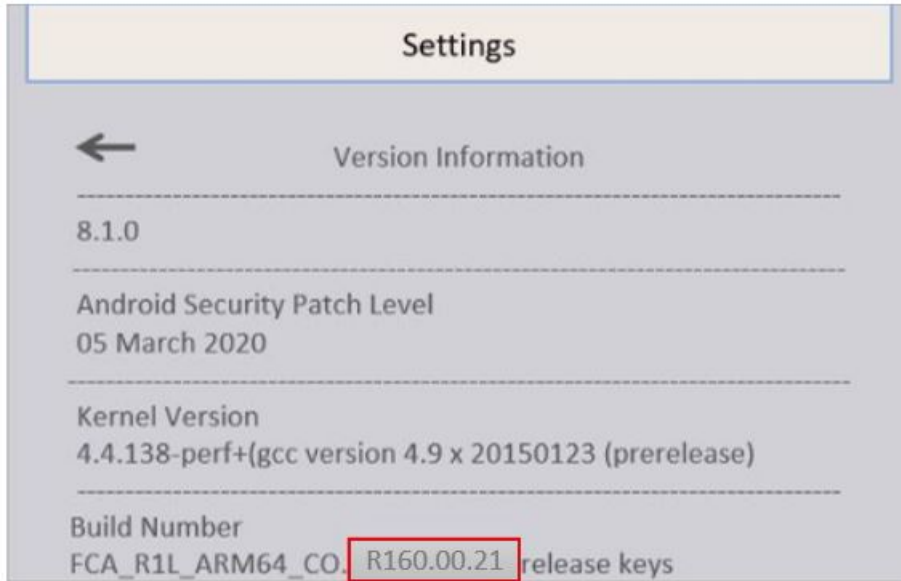
**Fig. 1
Radio Software Level Screen**

1. On the radio display screen go into “Vehicle Settings”.
2. Select “System Information”.
3. Select “Version Information”.
4. Under the “Build Number”, radio software version is listed. For example, the software version here is **R160.00.21 (Fig. 1) .

5. Is the current radio software one of the ones listed below?
 - 136.10.04
 - 136.09
 - 139.01.53
 - 145.00.15**
 - YES>>> Proceed to [Step 1](#) of the Repair Procedure.
 - NO>>> Proceed to [Step 6](#) of the Inspection Procedure.
6. Is the vehicle on the RSU VIN list?
 - YES>>> This bulletin has been completed. Use inspection LOP ****(18-60-03-AP)**** to close the active RSU.
 - NO>>> This bulletin does not apply to the vehicle, normal diagnostic should be performed.
