Technical Service Bulletin (TSB)
Driver Side Exterior Mirror Scratches

REFERENCE:	TSB: 23-084-23 GROUP 23 - Body	Date:	July 25, 2023	REVISION:	-
VEHICLES AFFECTED:	2022 - 2023 (WL) Jeep Grand Cherokee This bulletin applies to vehicles built on or before March 15, 2023 (MDH 0315XX) equipped with Power Mirrors-Base (Sales Code GUB) or Power Mirrors-High (Sales Code GUE) .	MARKET APPLICABILITY:			
CUSTOMER SYMPTOM:	Scratches on the driver side power folding mirror bracket.				
CAUSE:	Folding mirror gap below specification.

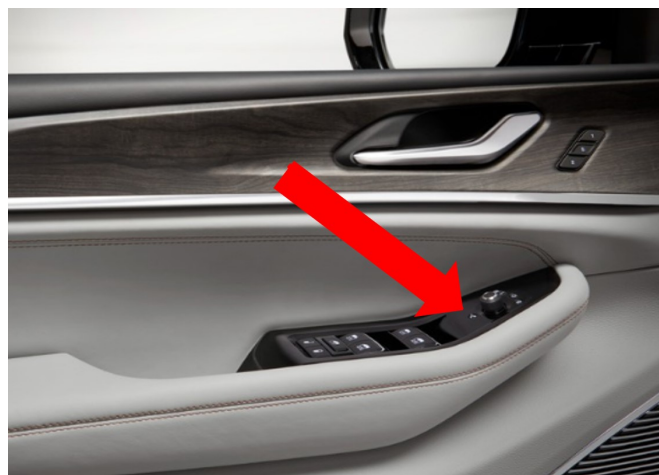
Fig. 1
Power Folding Mirror Button

2. Using the driver door power folding mirror button (Fig. 1) , cycle the exterior mirrors closed then open, three times.

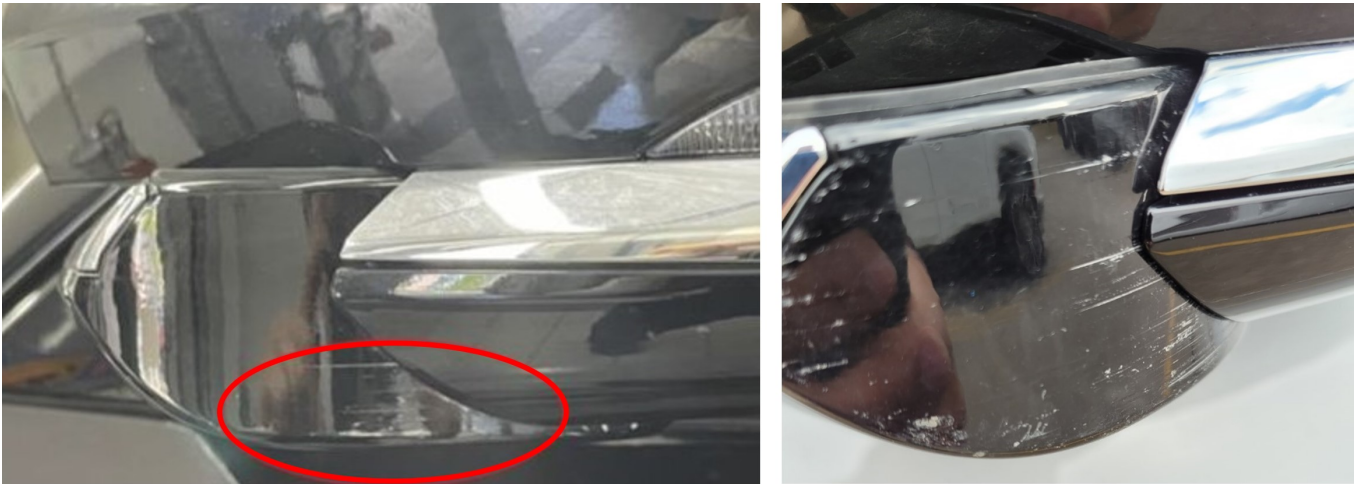
Fig. 2
Driver Door Mirror Bracket Scratches

3. Exit the vehicle.
4. Inspect the driver side exterior mirror mounting bracket for scratches (Fig. 2) .

5. Were any scratches found on the door mirror mounting bracket (Fig. 2) ?
 - YES>>> Proceed to [Step 1](#) of the Repair Procedure.
 - NO>>> This bulletin has been completed. Use inspect LOP (23-04-21-9V) to close the active RSU.

1. Replace the driver side exterior power folding mirror. Refer to the detailed service procedures available in DealerCONNECT> Service Library under: Service Info>23 - Body / Exterior / Mirror / Removal and Installation.
