## **Technical Service Bulletin (TSB)**

# Radio Over The Air Updating to QR40.12 Software Version

REFERENCE:	<b>TSB</b> : 08-181-23 <b>GROUP</b> 08 - Electrical	Date:	July 26, 2023	REVISION:	_
VEHICLES AFFECTED:				MARKET AF	PPLICABILITY:    MEA   IAP   CH
CUSTOMER SYMPTOM:	<ul> <li>Mobile Wi-Fi inoperative upon start up.</li> <li>Hotspot gives "No Internet" connection message on phone, when trying to connect to a device.</li> </ul>				
CAUSE:	Radio Software

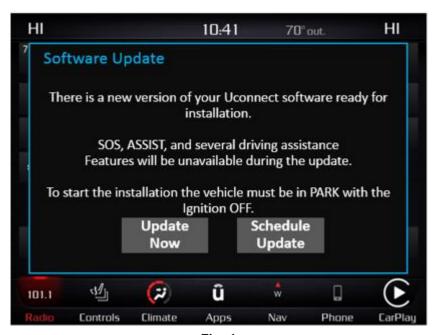
Fig. 1
Software Acceptance Screen

Customers will see a notification on their radio screen when new software is available for their radio (Fig. 1). The owner will have the option to update the radio or schedule the update for later. There is not an option to decline the update indefinitely, the update must be performed.

2. Whether the customer selects "Update Now", or "Schedule Update" (Fig. 1) and sets a time, they can shut off the vehicle and leave. The update will be completed automatically (Fig. 3).

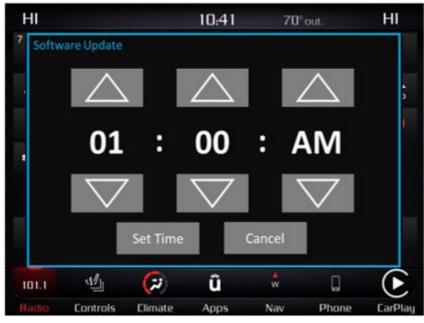
Fig. 2 Schedule Update Screen

NOTE: If selecting "Schedule Update" the screen below will be displayed. The customer can select the exact time they want the update to begin (Fig. 2).

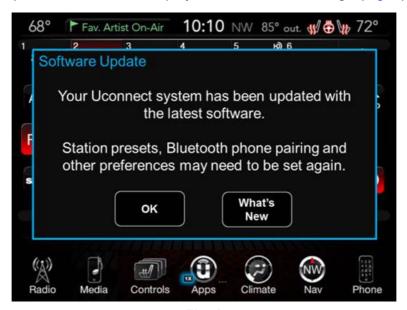
Fig. 4
Update Confirmation Screen

3. Upon completion of update, the radio will display a confirmation message (Fig. 4).
