REFERENCE:	TSB: 08-183-23 GROUP 08 - Electrical	Date:	July 26, 2023	REVISION:	
VEHICLES AFFECTED:	2020 (DJ) RAM 2500 Pickup 2020 (D2) RAM 3500 Pickup 2020 (DD) RAM 3500 Cab Chassis 2020 (DF) RAM 3500 <10K Cab Chassis 2020 (DP) RAM 4500/5500 Cab Chassis 2020 (DT) RAM 1500 Pickup NOTE: This bulletin applies to vehicles equipped with a Uconnect 12.0 With Navigation radio (Sales Codes UAX or UCX).			MARKET APPLICABILITY:	
				<input checked="" type="checkbox"/> NA	<input type="checkbox"/> IAP
				<input type="checkbox"/> EE	<input type="checkbox"/> MEA
				<input type="checkbox"/> SA	<input type="checkbox"/> CH
CUSTOMER SYMPTOM:	Customers may experience one or more of the following: <ul style="list-style-type: none"> • Mobile Wi-Fi inoperative upon start up. • Hotspot gives "No Internet" connection message on phone when trying to connect to a device. 				
CAUSE:	Radio software

REPAIR SUMMARY:

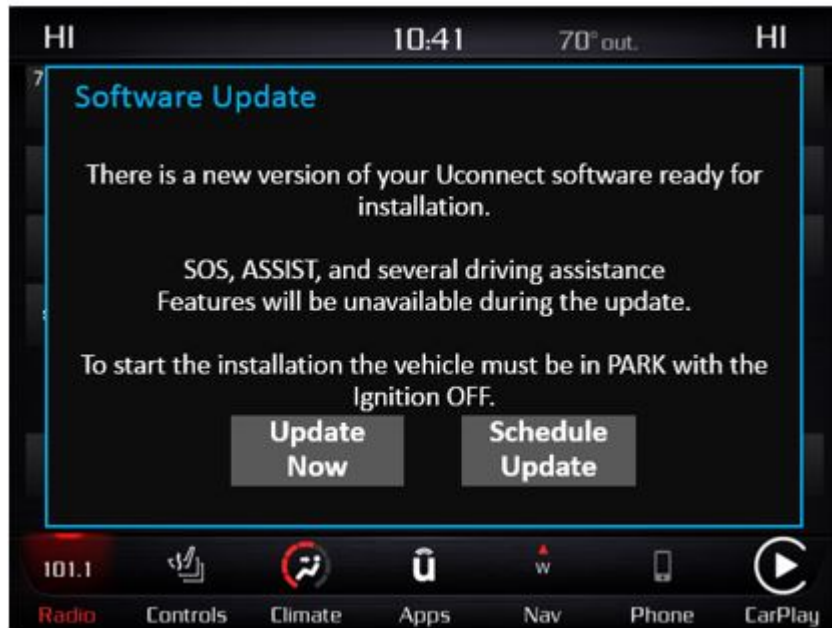
Fig. 1
Software Acceptance Screen

Customers will see a notification on their radio screen when new software is available for their radio (Fig. 1) . The owner will have the option to update the radio or schedule the update for later. **There is not an option to decline the update indefinitely, the update must be performed.**

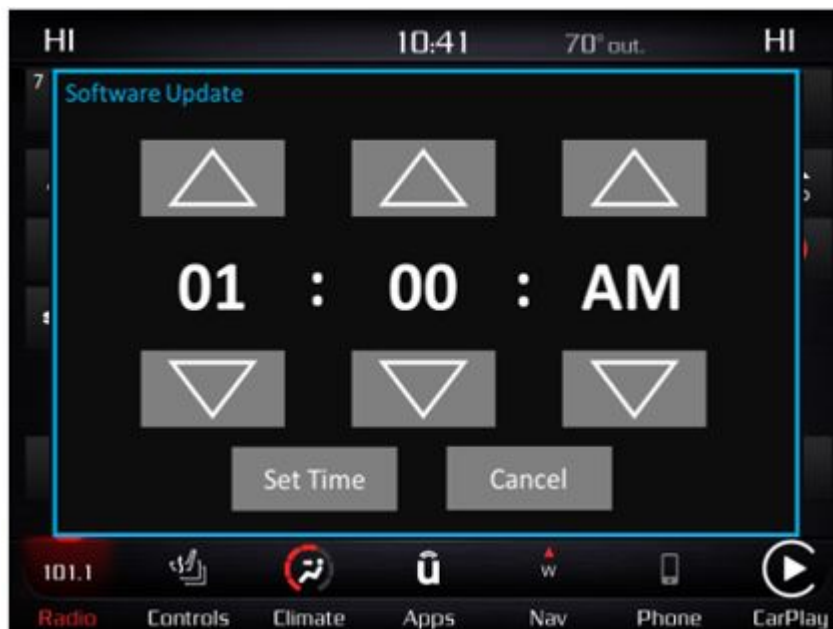
Fig. 2
Schedule Update Screen

NOTE: If selecting “Schedule Update” the screen below will be displayed. The customer can select the exact time they want the update to begin (Fig. 2) .

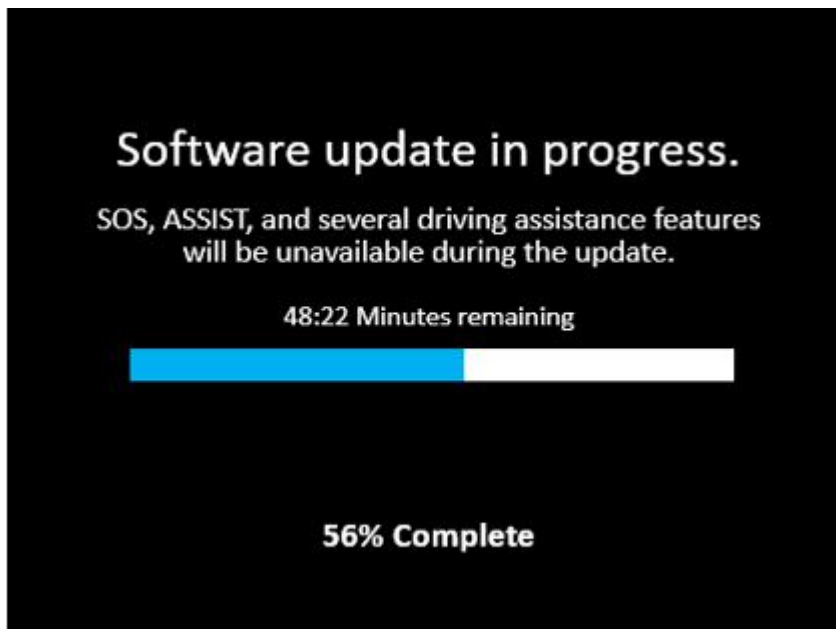
Fig. 3
Update In Progress Screen

- Whether the customer selects "Update Now" or "Schedule Update" (Fig. 1) and sets a time, they can shut off the vehicle and leave. The update will be completed automatically (Fig. 3) .

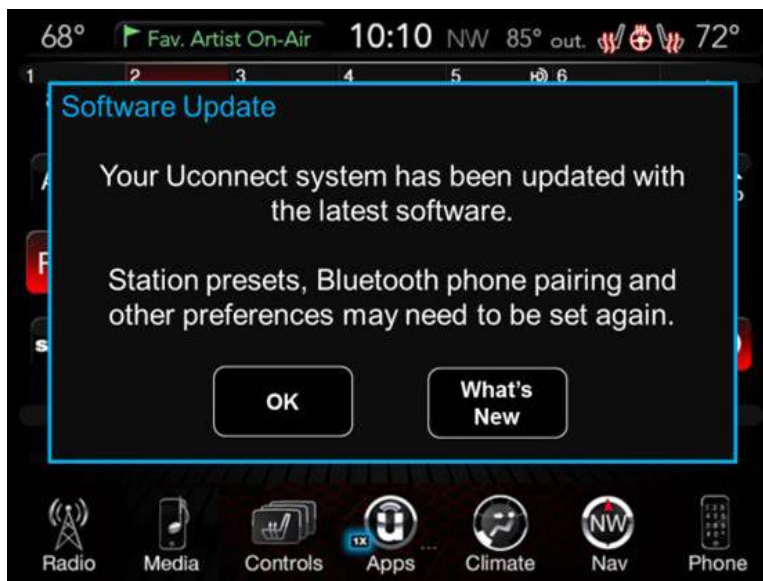
Fig. 4
Update Confirmation Screen

- Upon completion of update, the radio will display a confirmation message (Fig. 4) .
