Technical Service Bulletin (TSB)
ACC Etching on Start/Stop Button Shy

REFERENCE:	TSB: 08-184-23 GROUP 08 - Electrical	Date:	July 27, 2023	REVISION:	-
VEHICLES AFFECTED:	2023 (DT) RAM 1500 Pickup This bulletin applies to vehicles built on May 09, 2022 (MDH 0509XX) equipped with Remote Keyless Entry (Sales Code GXM).	MARKET APPLICABILITY:			
		<input checked="" type="checkbox"/> NA		<input type="checkbox"/> MEA	
		<input type="checkbox"/> SA		<input type="checkbox"/> IAP	
		<input type="checkbox"/> EE		<input type="checkbox"/> CH	
CUSTOMER SYMPTOM:	Customers may experience: <ul style="list-style-type: none"> ACC (Accessory Position) etching missing on Stop/Start button. 				
CAUSE:	Incorrect Stop/Start button installed.

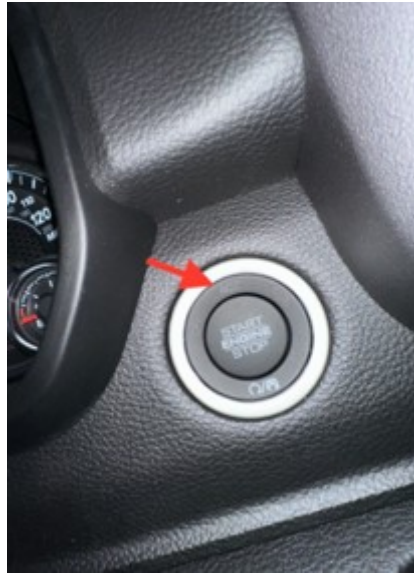
Fig. 1
Stop/Start Button

1. Inspect the Stop/Start button for missing ACC etching ([Fig. 1](#)) .

2. Is the ACC etching missing?
 - YES>>> Proceed to [Step 1](#) of the Repair Procedure.
 - NO>>> This bulletin does not apply. Use Inspect LOP (18-19-74-93) to close this active RSU.

1. Replace the KIN module. Refer to the detailed service procedures listed in DealerCONNECT>Service Library under: 08 - Electrical / 8E - Electronic Control Modules / Module, Keyless Ignition Node (KIN) / Removal and Installation.
