STELLANTIS PARTS & SERVICES Radio Over The Air Uconnect R1L R160				` ,	re Update to
REFERENCE:	TSB : 08-185-23 GROUP 08 - Electrical	Date:	July 28, 2023	REVISION:	_
VEHICLES AFFECTED:	2022 (DT) RAM 1500 Pickup 2022 (DJ) RAM 2500 Pickup 2022 (DD) RAM 3500 Cab Chassis 2022 (D2) RAM 3500 Pickup 2022 (DF) RAM 3500 10K LB. Cab Chassis 2022 (DF) RAM 4500/5500 Cab Chassis 2022 (DP) RAM 4500/5500 Cab Chassis 2022 - 2023 (DS) RAM 1500 Pickup This bulletin applies to vehicles equipped with the following radio: • Uconnect 5 W 8.4" Display (Sales Code UBD) and Global Telematics Box Module (Sales Code RDG). This bulletin applies to DS vehicles built on or before April 03, 2023 (MDH 0403XX).			MARKET APPLICA ⊠ NA □ SA □ EE	ABILITY: MEA IAP CH
CUSTOMER SYMPTOM:	 Customers may experience one or more of the following: Media source changes to AM after the theme mode is changed (ex. headlights on - dark mode). Audio cuts out at volume levels 30 or above. System switches to Wireless after key cycle, profile change, or theme mode change. Wireless phone interface freezes after user accepts incoming call when in a conference call. Wi-Fi Hotspot gets disabled automatically when turning the vehicle igniti

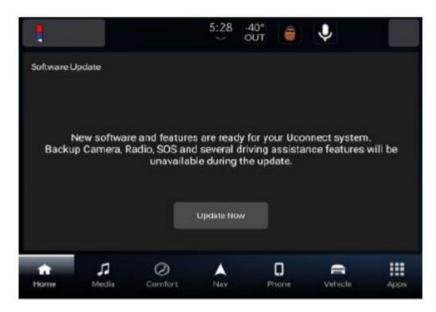
Fig. 1
Software Acceptance Screen

- 1. The vehicle needs to be in 'Park'. The ignition needs to be in the off position.
- 2. If the customer selects "Update Now" (Fig. 1) they can shut off the vehicle and leave. The update will be completed automatically.

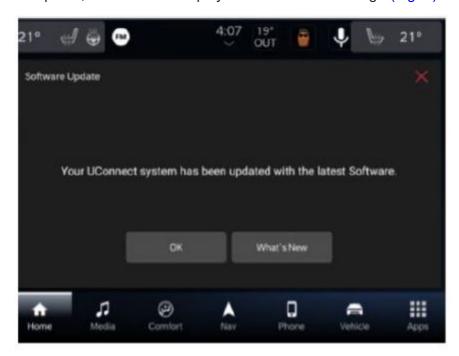
Fig. 2
Software Update Confirmation Screen

3. Upon completion of update, the radio will display a confirmation message (Fig. 2).
