**Technical Service Bulletin (TSB)**  
**Front Right Fender is not Flush with Passenger Door**

<b>REFERENCE:</b>	<b>TSB:</b> 23-086-23 <b>GROUP</b> 23 - Body	<b>Date:</b>	July 28, 2023	<b>REVISION:</b>	-
<b>VEHICLES AFFECTED:</b>	2023 (WS) Grand Wagoneer/Wagoneer This bulletin applies to vehicles built on or after April 13, 2023 (MDH 0413XX) and on or before May 15, 2023 (MDH 0515XX).			<b>MARKET APPLICABILITY:</b>	
				<input checked="" type="checkbox"/> NA	<input type="checkbox"/> CH
				<input type="checkbox"/> EE	<input type="checkbox"/> IAP
				<input type="checkbox"/> SA	<input checked="" type="checkbox"/> MEA
<b>CUSTOMER SYMPTOM:</b>	Front right fender (passenger side) is not flush with door.				
<b>CAUSE:</b>	Fender out of specification.

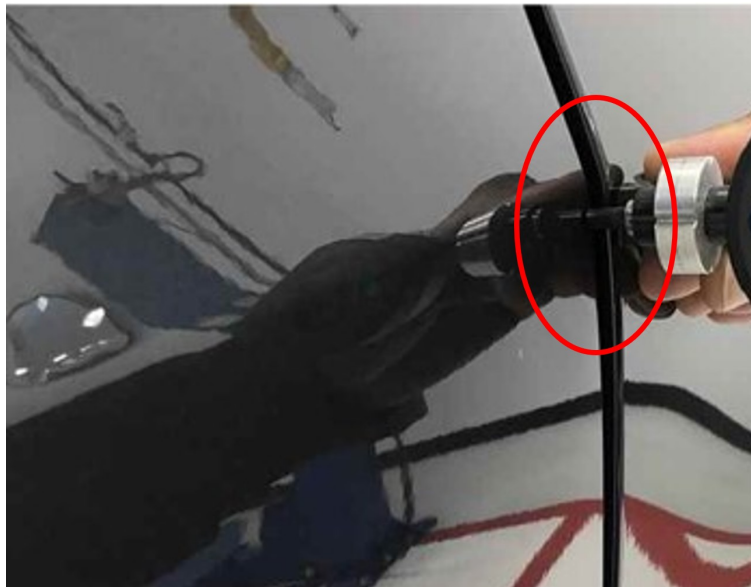
Fig. 1

**NOTE: This Inspection Procedure involves inspecting the front right fender only. Do not inspect the front left fender. Fender can be up to 3.0 mm (0.11 in.) overflush.**

- Using a 0.5 mm (0.01 in.) gauge, measure the front right fender for an overflush condition to the passenger door at the body line (Fig. 1) .

#### Front Right Fender Overflush

- Was the front right fender overflush to the door (Fig. 1) ?
  - YES>>> Proceed to [Step 1](#) of the Repair Procedure.
  - NO>>> This bulletin does not apply. Use the Inspection LOP (23-00-15-96) to close the active RSU.

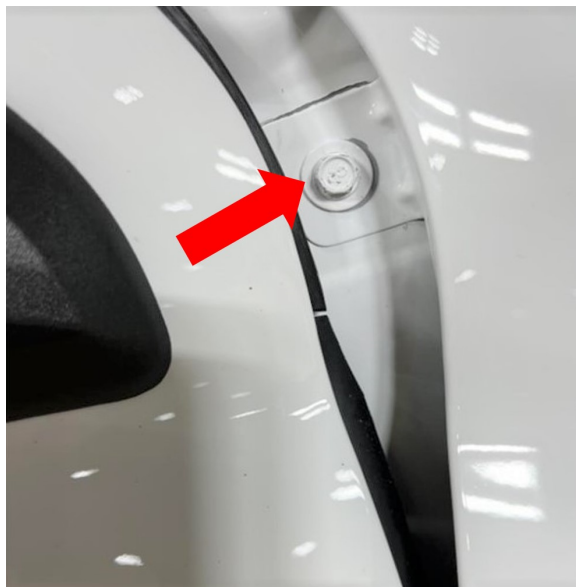
**Fig. 2**  
**Fender Bolt At A-Pillar**

1. Fully open the front passenger side door.
2. Locate the fender bolt attached to the A-pillar (Fig. 2) .

3. Loosen but do not remove the fender bolt (Fig. 2) .
4. Adjust the fender until it is within flushness specification of 0.5 mm (0.01 in.) to the passenger door.
5. Tighten the fender A-pillar bolt to 10.5 N·m (7.7 ft. lbs.).
6. Touch up any chipped paint on the A-pillar bolt (Fig. 2) .
