TECHNICAL SERVICE BULLETIN

AWD - Hybrid - Driveline Vibration At 25-50 MPH (40-80 Km/h)

23-2072
19 September
2023

Ford 2020-2023 Explorer	AWD Hybrid
Lincoln 2020-2023 Aviator	AWD Hybrid

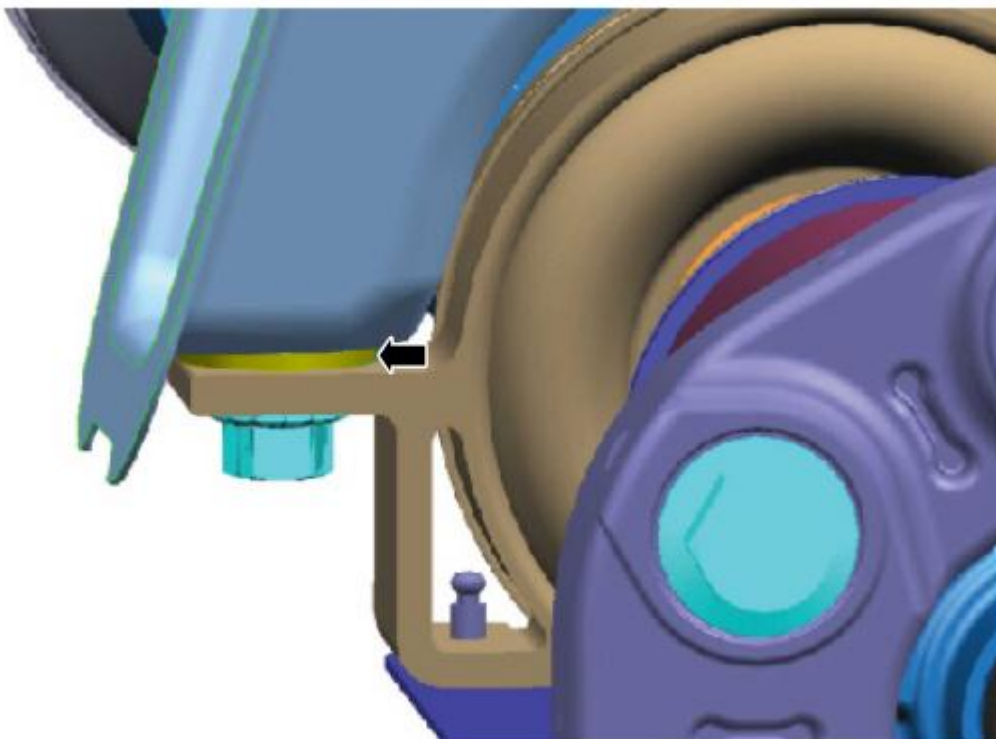
Figure 1

Issue: Some 2020-2023 Explorer/Aviator all-wheel drive (AWD) vehicles with a hybrid powertrain may experience a harshness and/or vibration felt through the seat, steering wheel and/or center console at 25-50 mph (40-80 km/h). This may be due to constant velocity (CV) joint instability at dynamic angles close to zero. To correct the condition, follow the Service Procedure to install a driveline shim.

1. Remove one of the driveshaft center bearing bolts. Do not remove or loosen both bolts at the same time.
2. Insert the shim between the driveshaft center bearing bracket and the body where the bolt was removed (Figures 1-2).
