TECHNICAL SERVICE BULLETIN

Chassis Cab/Cutaway - False BLIS® Warning/Indication Or Too Sensitive While Driving - Built On Or Before 15-Mar-2023

23-2284

Ford 2023 Transit	Built on or before 15-Mar-2023
-----------------------------	--------------------------------

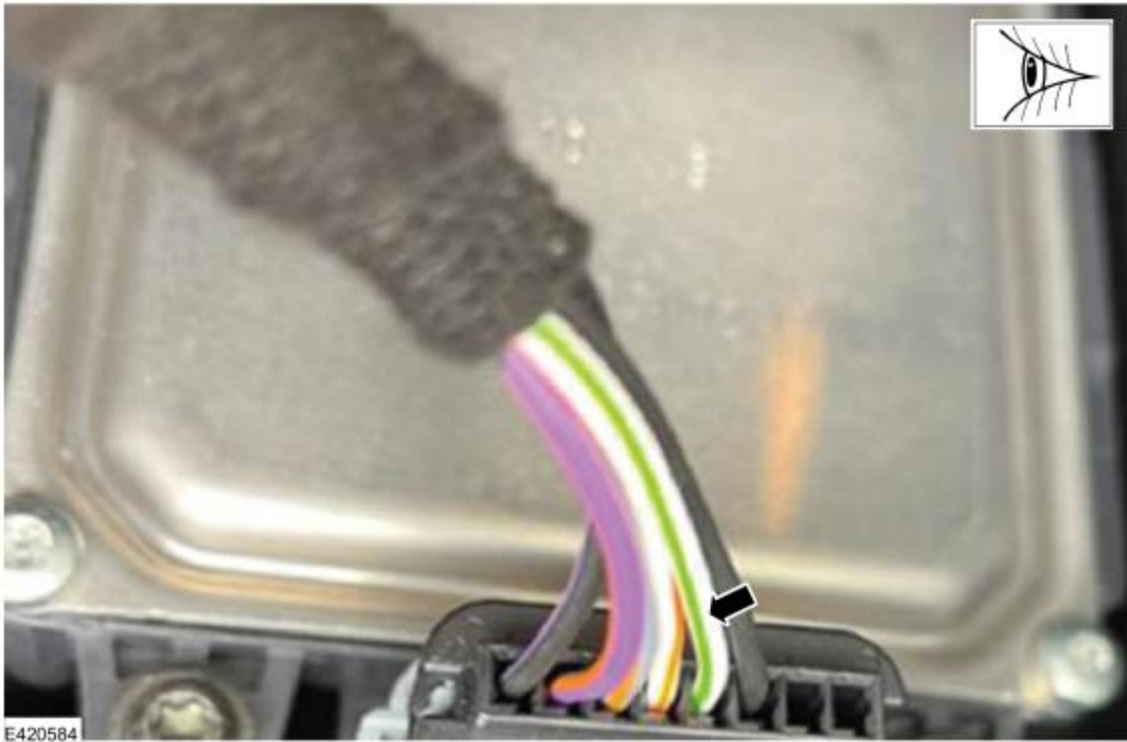
Figure 1

Issue: Some 2023 Transit chassis cab/cutaway vehicles equipped with the blind spot information system (BLIS®) kit built on or before 15-Mar-2023 may experience a false BLIS® warning/indication or too sensitive while driving. This may be due to a lack of module configuration and/or incorrect harness connector being connected to the side obstacle detection left or right (SODL/SODR) module. To correct the condition, follow the service procedure to reconfigure SODL and SODR modules or verify that the BLIS harness connector is connected correctly.

- (1). Yes - proceed to Step 3.
 - (2). No - the repair is complete.
3. Locate and remove both side obstacle detection control modules (SODR/SODL). Verify the connector C4369 with the circuit CRB03 (WH-GN) pin 4 is connected to the left side obstacle detection control module (SODL) and the connector C4370 with the circuit CRB01 (VT-BN) pin 4 is connected to the right side obstacle detection control module (SODR). (Figure 1 and 2). If the harness connectors are in the wrong SODL or SODR, unplug and install the connectors correctly, rerouting and securing the harness as necessary.
