SIB 65 27 23

APPLE CARPLAY® VARIOUS OPERATIONAL FAULTS

2023-09-08

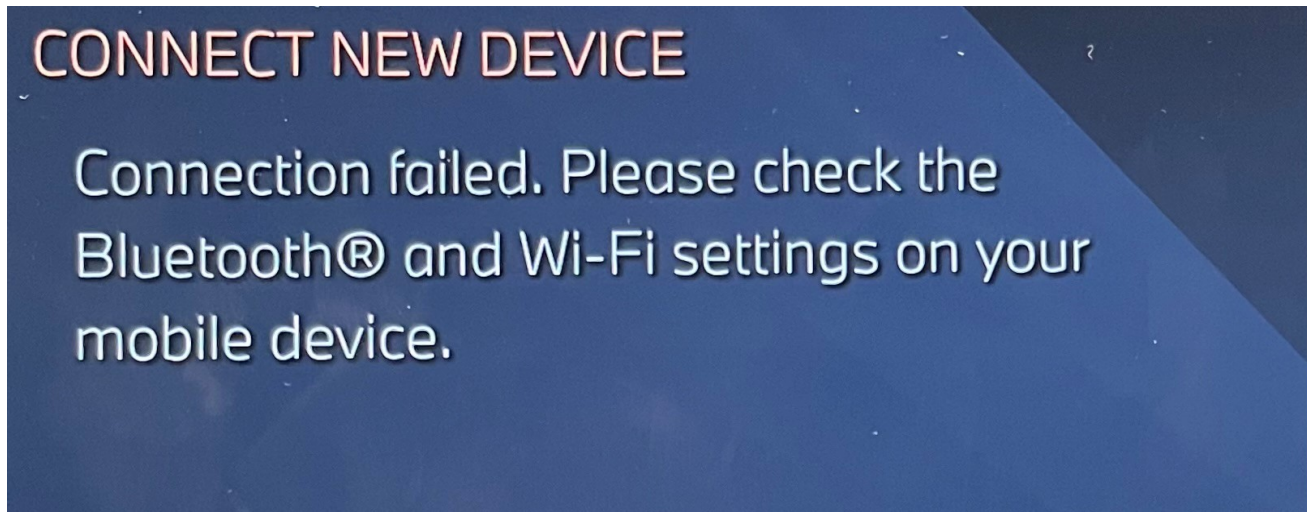
- No selections can be made in Apple CarPlay® using the I-Drive Controller
- Apple CarPlay® connections may intermittently be dropped and reconnected
- When connecting a mobile device using Apple CarPlay®, the following warning pop-up may be displayed

Unfavorable software in the head unit (HU-H5).

Program the head unit (HU-H5).
