SIB 64 03 22
NO HEATER OUTPUT IN PASSENGER AREA

2023-09-08

This Service Information Bulletin (Revision 1) replaces SI 64 03 22 **dated March 2022**.

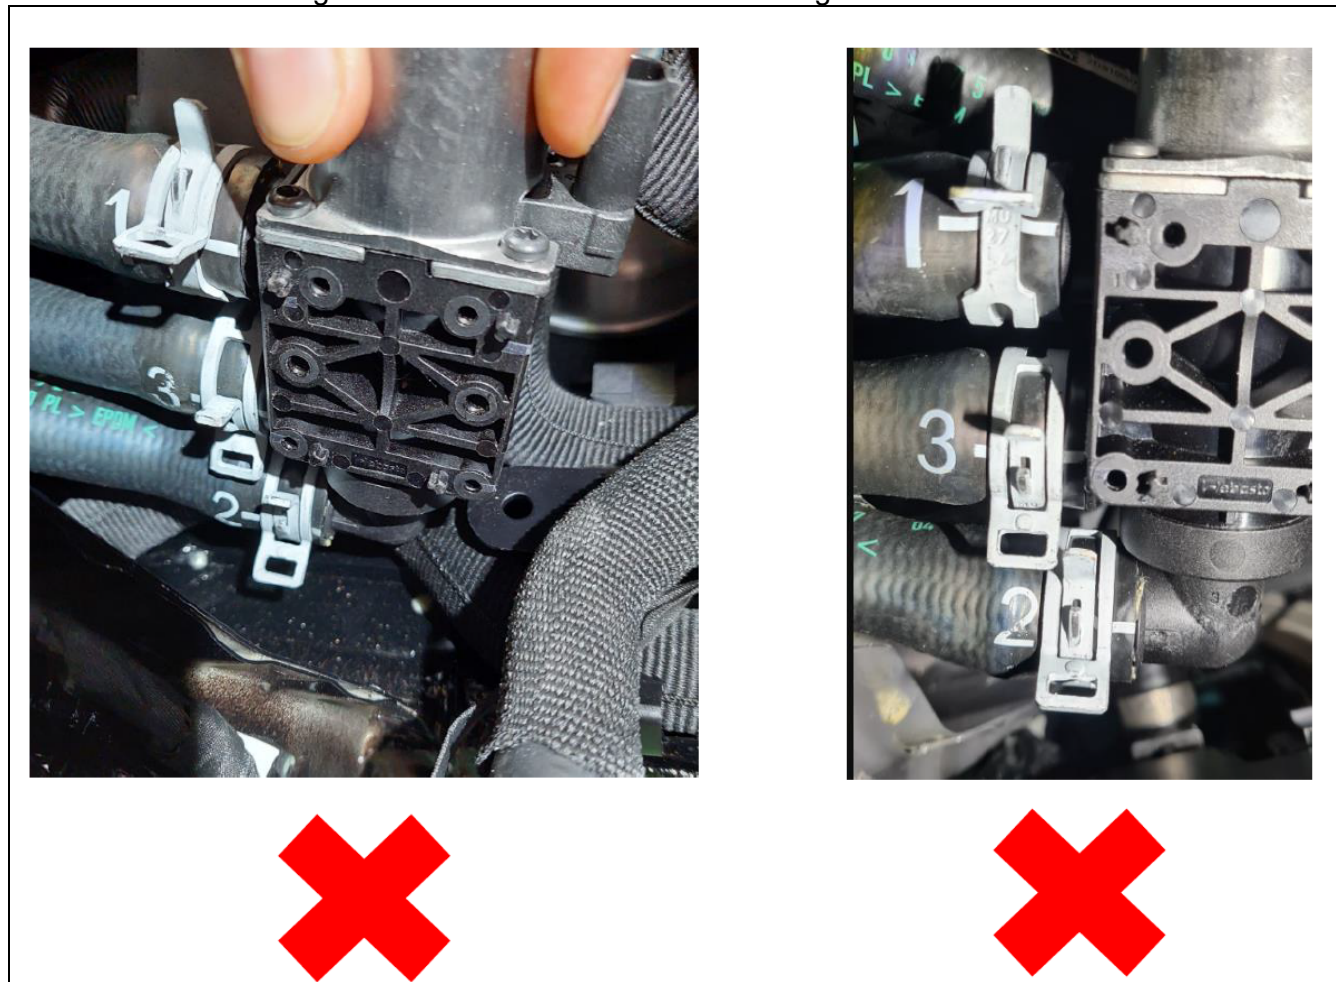
The hoses on the changeover valve are mounted in the wrong order.

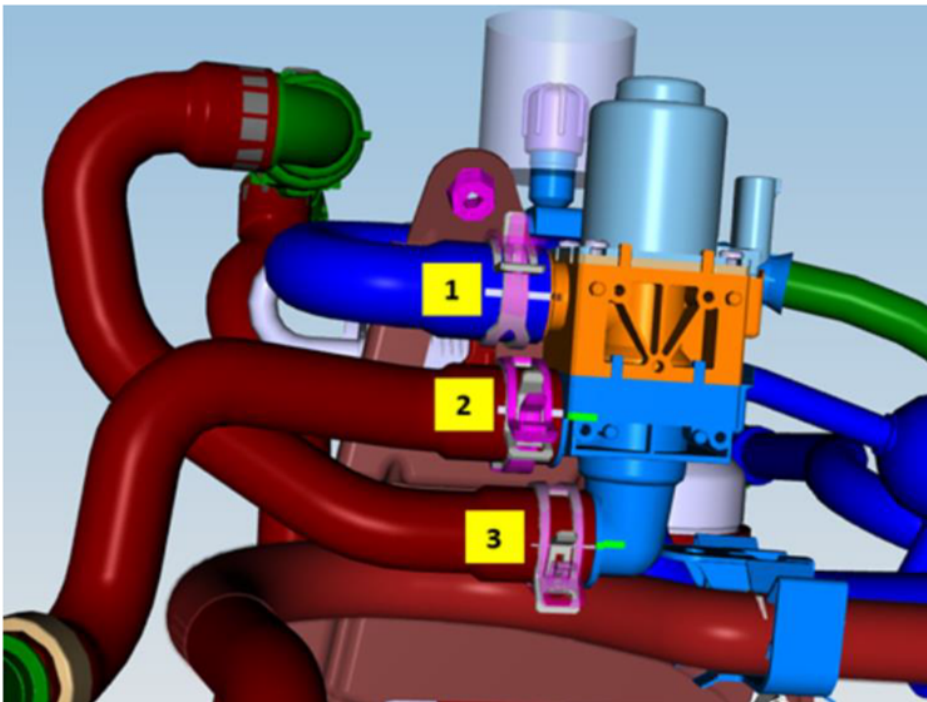
1. Set the heating in the passenger area to the maximum temperature and check whether warm air is detected at the air vent.
2. If no warm air is coming out of the air vents, the vehicle's fault memory must be checked.
3. If no relevant fault memory entry has been saved, check the 3 hoses on the changeover valve (in the engine compartment) for correct installation.
 - The hoses on the changeover valve are numbered consecutively from top to bottom
 - Check whether the sequence 1 to 3 from top to bottom was maintained

4. If the sequence is incorrect, mount the corresponding hoses on the changeover valve in the correct order
 - Risk of scalding!
 - Disconnect hoses only when the engine and heating circuit have cooled down:
 - Refer to AIR 64... for safety warnings on working with the heating circuit
5. Reassess the vehicle.
