SIB 63 11 23

MOISTURE/CONDENSATION IN THE DRL HEADLIGHT

E-Series	Model Description
G07 LCI	X7 Sports Activity Vehicle
G09	BMW XM Sports Activity Coupe
G70	7 Series Sedan

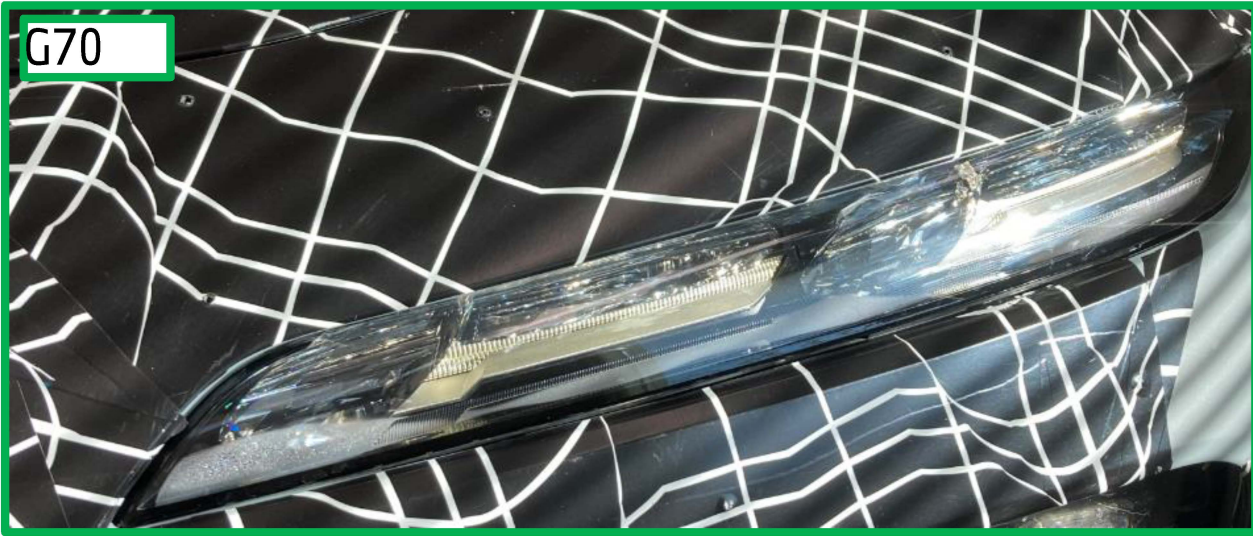
A

- Images marked with a green "A" show examples of headlights with naturally occurring condensation
- Images marked with a red "B" show examples of headlights which have been found defective
