SIB 51 18 23

GROANING NOISE FROM THE WEDGING ELEMENT ON THE TRUNK LID

E-Series	Model Description
G26	4 Series Gran Coupe

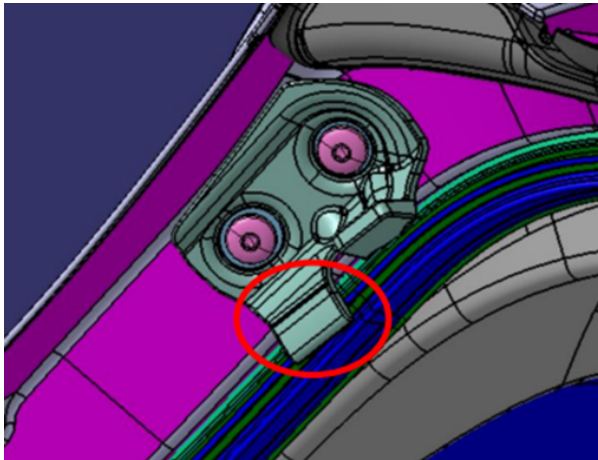
A groaning noise is heard from the trunk when driving on rough roads.

- Clean and lubricate the trunk lid wedging element using Berucoat AK 978.

- Adjust the trunk lid following repair instructions listed in ISTA/AIR.

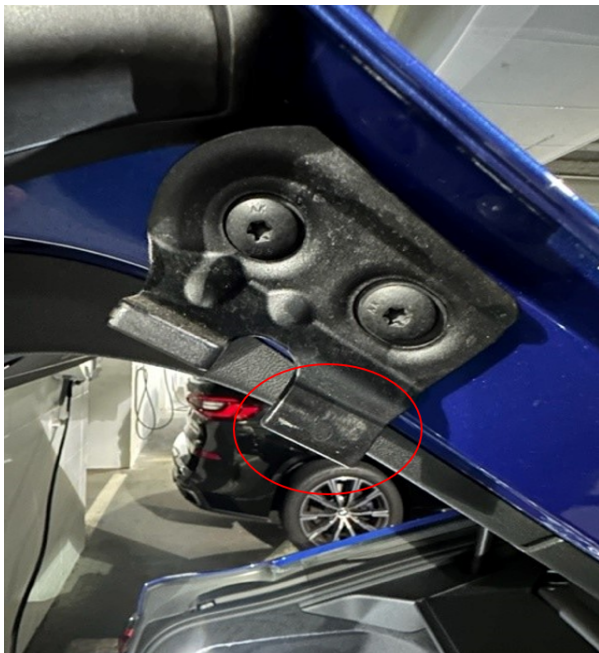
Unfavorable gap tolerance between wedging element on trunk lid and stop pad on vehicle body.

- Clean the wedging element on the trunk lid with denatured alcohol mixed with water using a clean rag.
- Apply Berucoat AK 978 to the wedging element.
- Allow Berucoat AK 978 to dry for 8 minutes with the trunk lid open.

- Adjust the trunk lid following repair instructions listed in ISTA/AIR (41 62 014).
