SIB 51 15 23

2023-09-06

TAILGATE/TRUNK WILL NOT UNLATCH OR OPEN

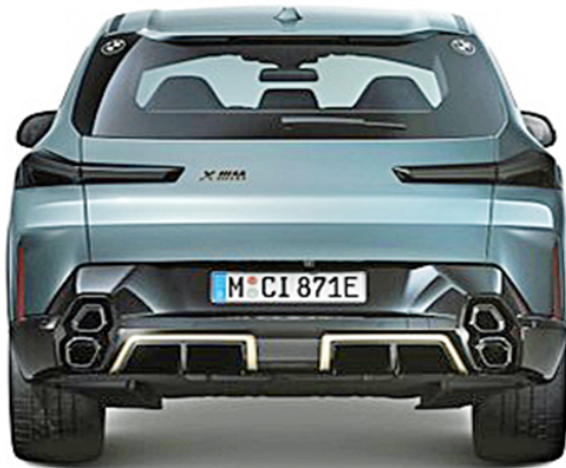
The tailgate/trunk will not unlatch or open when signaled via the interior button (driver's door panel) or the key fob.

Photo of the tailgate on the G09 (XM)

The tailgate/trunk latch is internally short circuited.

Replace the tailgate/trunk latch.

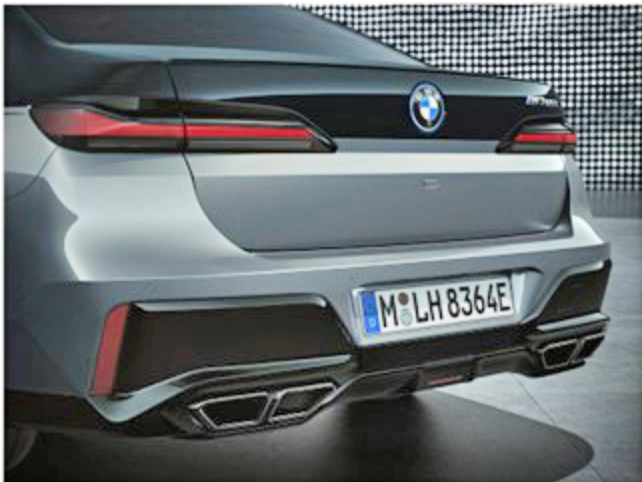
Photo of the trunk on the G70 (7 Series)
