Service Update

A232415800 Radio Module Software Update

Release Date: September 2023

Models: 2024 Buick Encore GX
2024 Chevrolet Trax
Equipped with INFOTAINMENT-VIRTUAL COCKPIT SYS - ENTRY
(RPO IVA)

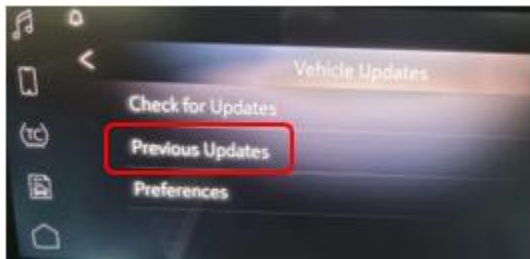
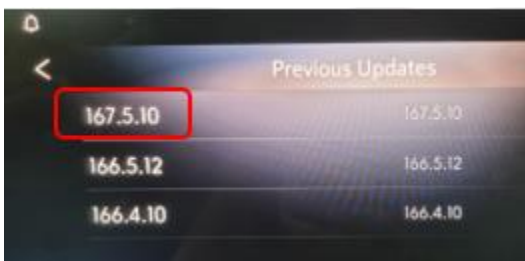
1. Inspect the current radio software version.
Navigate to Settings -> Vehicle Update -> Previous Update to view and verify the software version.

- If the software version is 167.5 or greater, this update does not apply. No further action required.
 - If the software version is less than 167.5, update the radio software via USB and reprogram the radio module with SPS.
2. Reprogram the radio. On the SPS Supported Controllers screen, select A11 Radio – USB Copy/ USB File Transfer. Refer to *A11 Radio: Programming and Setup* in SI.
 3. Reprogram the radio. On the SPS Supported Controllers screen, select A11 Radio – Programming and then follow the on-screen instructions. Refer to *A11 Radio: Programming and Setup* in SI.
