Subject: A232415800 - Service Update
Radio Module Software Update

Models: 2024 Buick Encore GX
2024 Chevrolet Trax
Equipped with INFOTAINMENT-VIRTUAL COCKPIT SYS - ENTRY
(RPO IVA)

Service Update

A232415800 Radio Module Software Update

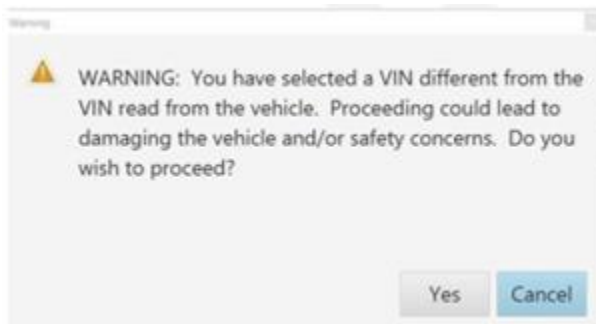
5877000

Important: If the vehicle VIN DOES NOT match, the message below will be shown.

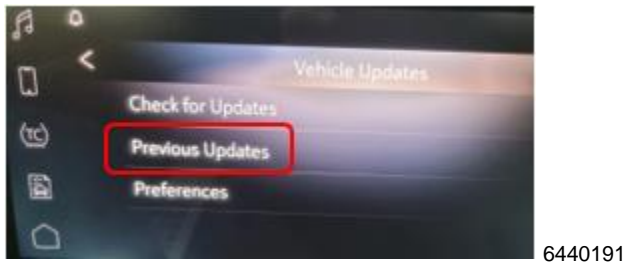
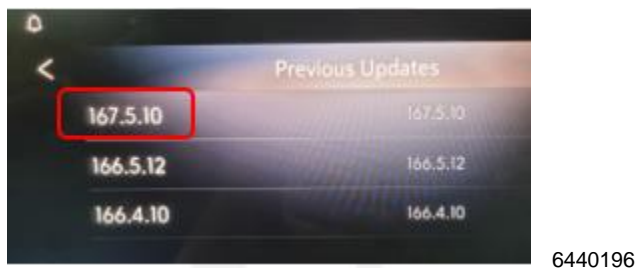
1. Inspect the current radio software version.
Navigate to Settings -> Vehicle Update -> Previous Update to view and verify the software version.

- If the software version is 167.5 or greater, this update does not apply. No further action required.
 - If the software version is less than 167.5, update the radio software via USB and reprogram the radio module with SPS.
2. Reprogram the radio. On the SPS Supported Controllers screen, select A11 Radio – USB Copy/ USB File Transfer. Refer to *A11 Radio: Programming and Setup* in SI.
 3. Reprogram the radio. On the SPS Supported Controllers screen, select A11 Radio – Programming and then follow the on-screen instructions. Refer to *A11 Radio: Programming and Setup* in SI.
