GROUP	MODEL
Subsequent Repair Action	2015-2019MY Soul EV (PS EV)
NUMBER	DATE
SC267Z	September 2023

# HIGH-VOLTAGE BATTERY PACK ASSEMBLY REPLACEMENT (SC267Z)

This bulletin provides information to replace the high-voltage battery pack assembly (HV BPA) on certain 2015-2019MY Soul EV (PS EV) vehicles produced from July 15, 2014 through September 28, 2018. After completing SC267 with the battery management system (BMS) software upgrade, the subject vehicles may subsequently require the replacement of the HV BPA due to MIL ON with a BPA related DTC(s). Follow the procedure outlined in this publication to scan the vehicle for related DTC(s), replace the HV BPA and if applicable, swap the voltage and temperature sensor harness (on 15-17MY vehicles only). Before conducting the procedure, verify that the vehicle is included in the list of affected VINs.

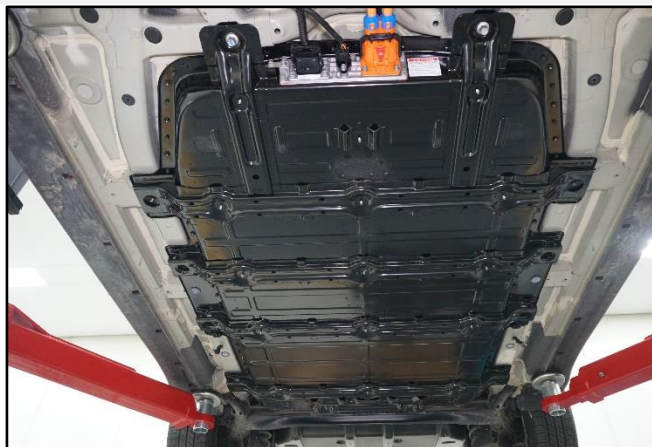
**15-17MY ONLY** new **BPA** is equipped with an "old" type harness. **Be sure to swap/install the "new" type harness.**

1. Replace the HV BPA by referring to "EV Battery System → High Voltage Battery System → Battery Pack Assembly → Repair procedures (Removal)" in the applicable Shop Manual on KGIS. **Note: Dealer must obtain TL PWA.**

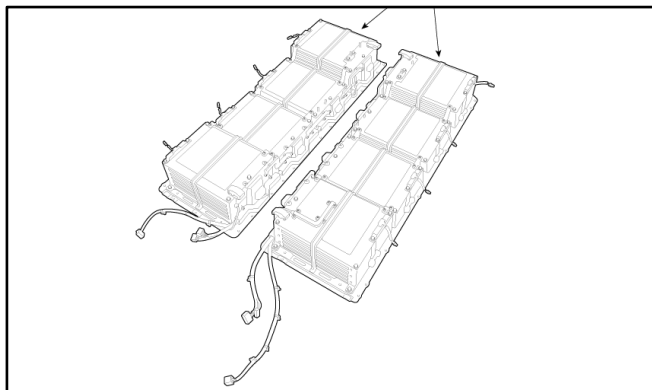
**18-19MY ONLY** new **BPA** is equipped with the "new" type harness. **There is no need to swap.**

3. **Note:** The battery pack assembly (BPA) consists of two (2) (left and right) battery packs.

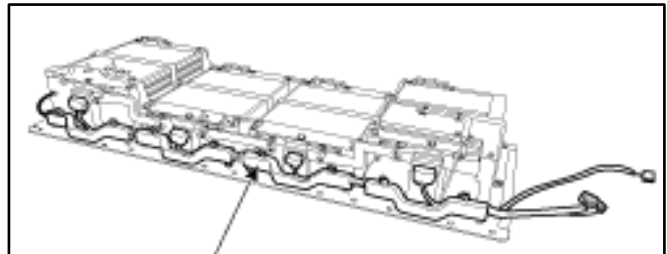
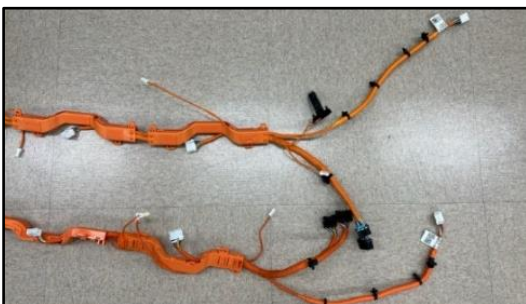
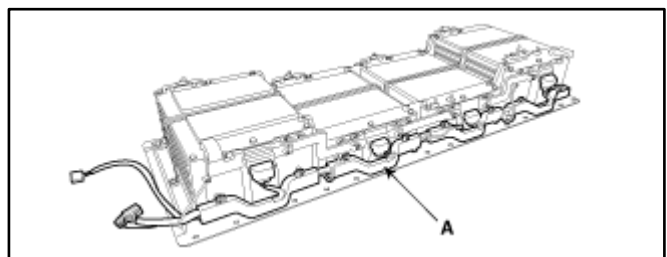
**Note:** The new harness is different for the removed harness when compared side by side.

4. Replace the two voltage temperature sensor wire harnesses (VTSWH) with the new parts.

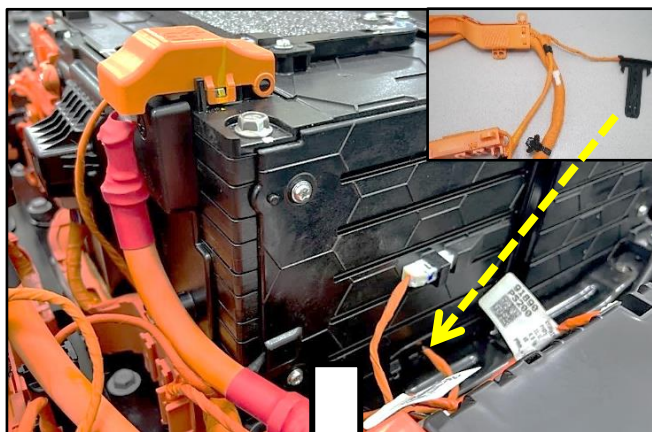
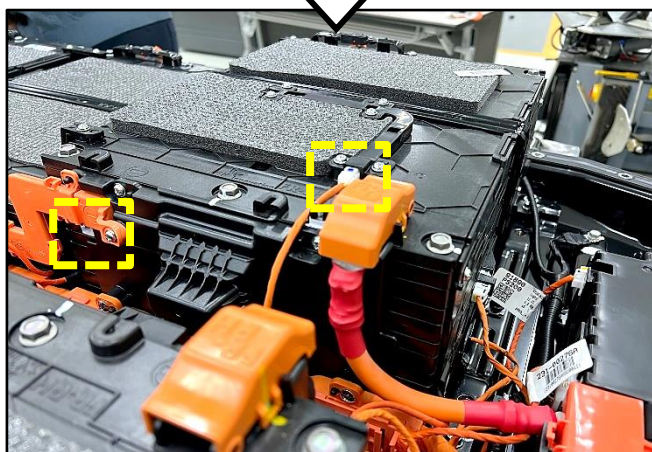
**Note:** Some vehicles may have a connector hole. If so, disregard, no need to connect to it.

5. During re-assembly, insert the battery temperature sensor into the battery pack lower side area shown.
6. Connect the outside temperature sensor connector where shown.
