GROUP	MODEL
TRA	2021-2023MY Multiple Models
NUMBER	DATE
108	September 2023

TECHNICAL SERVICE BULLETIN

SUBJECT: **4WD COUPLING ACTUATOR ASSEMBLY REPLACEMENT**

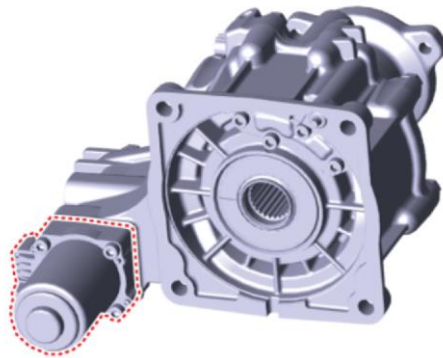
This bulletin provides information to replace the AWD coupling actuator assembly on some 2021-2023MY Kia AWD models listed on page 4. The affected vehicles may exhibit an inoperative AWD system (also referred to as 4WD) capability concern which may be caused by abnormal wear of the motor brushes inside the actuator assembly. This condition will cause the warning lamps on the instrument cluster to illuminate with stored DTC(s) P195800 and/or P19600. Follow the procedure outlined in this publication to inspect and, if necessary, replace the AWD coupling actuator assembly on the applicable vehicles.
