# Service Bulletin

Bulletin No.: 21-NA-220

**Subject: Loss of Power, Malfunction Indicator Lamp (MIL) Illuminated, Gauges Inoperative and/or Multiple Warning Lights/Messages Displayed on Driver Information Center (DIC) – Multiple DTCs Set**

Brand:	Model:	Model Year:		VIN:		Engine:	Transmission:
		from	to	from	to		
Chevrolet	Malibu	2016	2024	—	—	1.5L Turbo (LFV)	—

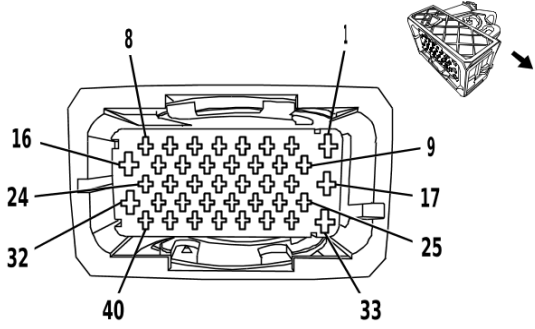
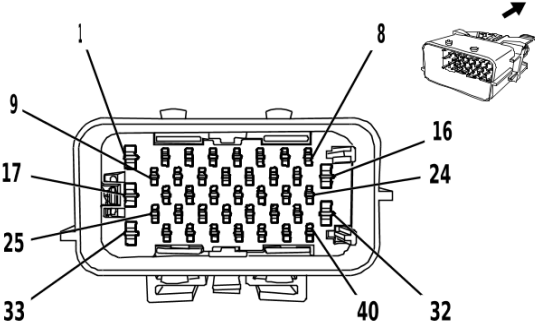
<b>Involved Region or Country</b>	North America, Israel, Palestine
<b>Condition</b>	<p>Some customers may comment on one or more of the following conditions:</p> <ul style="list-style-type: none"><li>• Loss of power</li><li>• MIL illuminated</li><li>• Gauges dropping out</li><li>• Multiple warning lights and/or messages</li></ul> <p>Technicians may find one or more of the following DTCs stored in the Engine Control Module (ECM):</p> <ul style="list-style-type: none"><li>– P0700, P150C, P15FD, P2544, P308D, U0073, U0101, U0129, U0140, U0146, U183A, U18D5, U18D7, U2413, U0121, U0100, U0401, U0131</li></ul>
<b>Cause</b>	This condition may be caused by high resistance on the HSCAN BUS circuits 2500/2501 between the Electronic Brake Control Module (EBCM) and the Power Steering Control Module (PSCM).

<p>2339640</p> </div> <p>With the battery disconnected, verify the resistance of the HSBUS circuits across 2500, 2501 splitting the circuit at the X115 electrical connector. Refer to Master Electrical Component List in SI. Looking for any unwanted resistance (ex. 126.7 or something other than in the range of 120 ohms). If stray resistance is traced down to one of the module connector terminals, verify terminal tension and ensure there is no damage to the terminal. If the terminal is good, then apply dielectric grease to the terminals.</p> <p>If the terminals are damaged or have poor terminal tension, replace with terminated leads at the suspect module connector and apply dielectric grease to the connector.</p>
-------------------	---
