Service Bulletin

Bulletin No.: 23-NA-058

Subject: Cold Start Rattle Noise from the Engine Compartment, Malfunction Indicator Lamp (MIL) Illuminated - DTC P0299 Set

Brand:	Model:	Model Year:		VIN:		Engine:	Transmission:
		from	to	from	to		
Buick	Encore GX	2020	2023			1.2L (LIH)	
Chevrolet	Trailblazer	2021

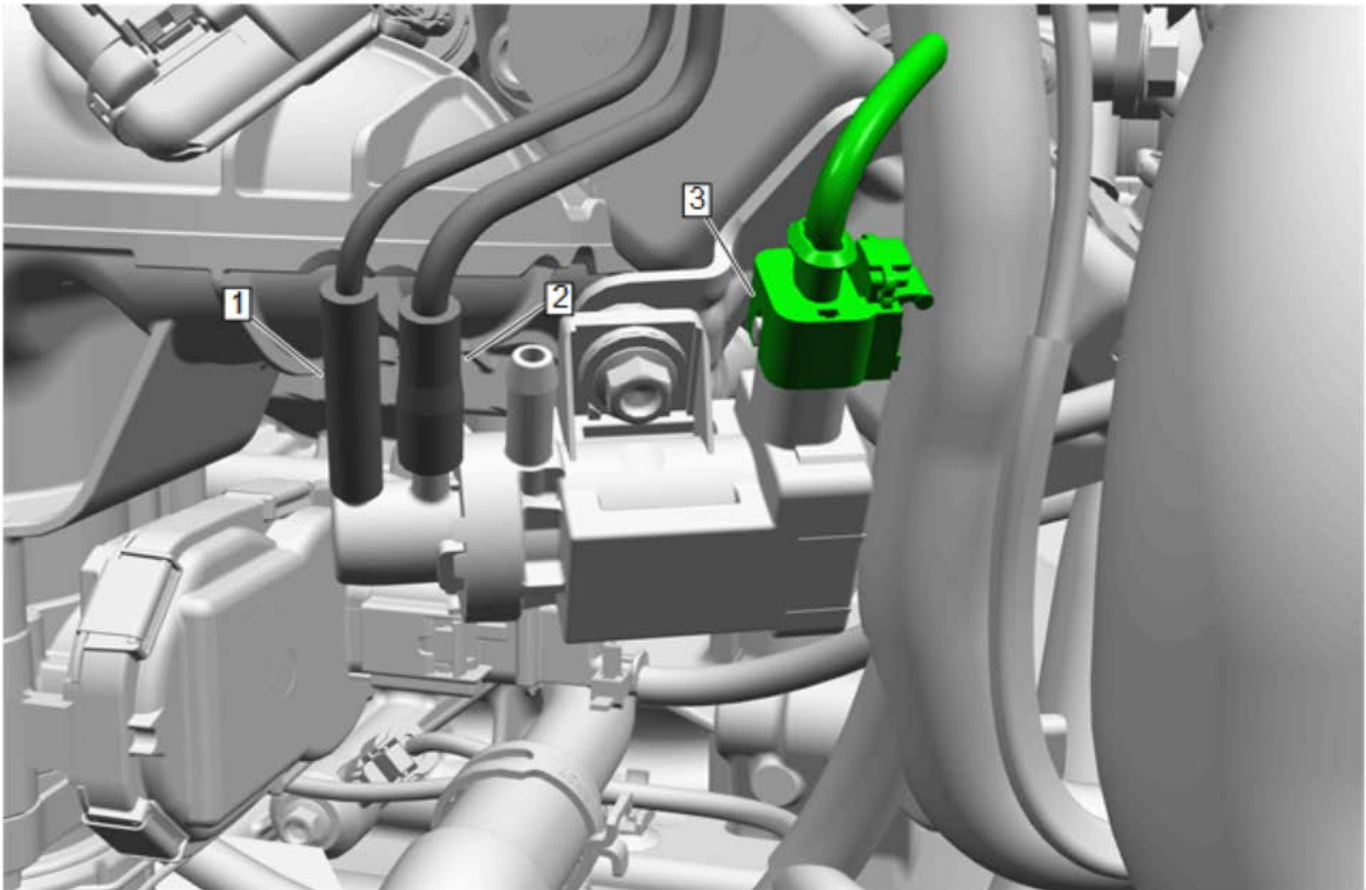
5392518

1. Disconnect the Turbocharger Wastegate Actuator Vacuum Control Solenoid Valve Hose (1) from the Turbocharger Wastegate Regulator Solenoid Valve.
2. Utilizing EN-23738-A Vacuum Pump with an integral vacuum gauge, connect said pump to the Turbocharger Wastegate Actuator Vacuum Control Solenoid Valve Hose.

3. Engine at operating temperature at idle.
4. Verify the tool reading: EN-23738-A Vacuum Pump = -50 kPa (-0.5 bar, 15 in Hg).
 - If the desired pressure/vacuum cannot be achieved or does not hold steady:

- ⇒ Ignition/Vehicle » Off.
 - ⇒ Test or replace the component: Vacuum Pump Assembly and related hoses.
 - If the desired pressure/vacuum can be achieved and holds steady:

- Engine » Off.
 - Reconnect the Turbocharger Wastegate Actuator Vacuum Control Solenoid Valve Hose to the Turbocharger Wastegate Regulator Solenoid Valve and refer to Check Wastegate Vacuum Regulator Valve Function.

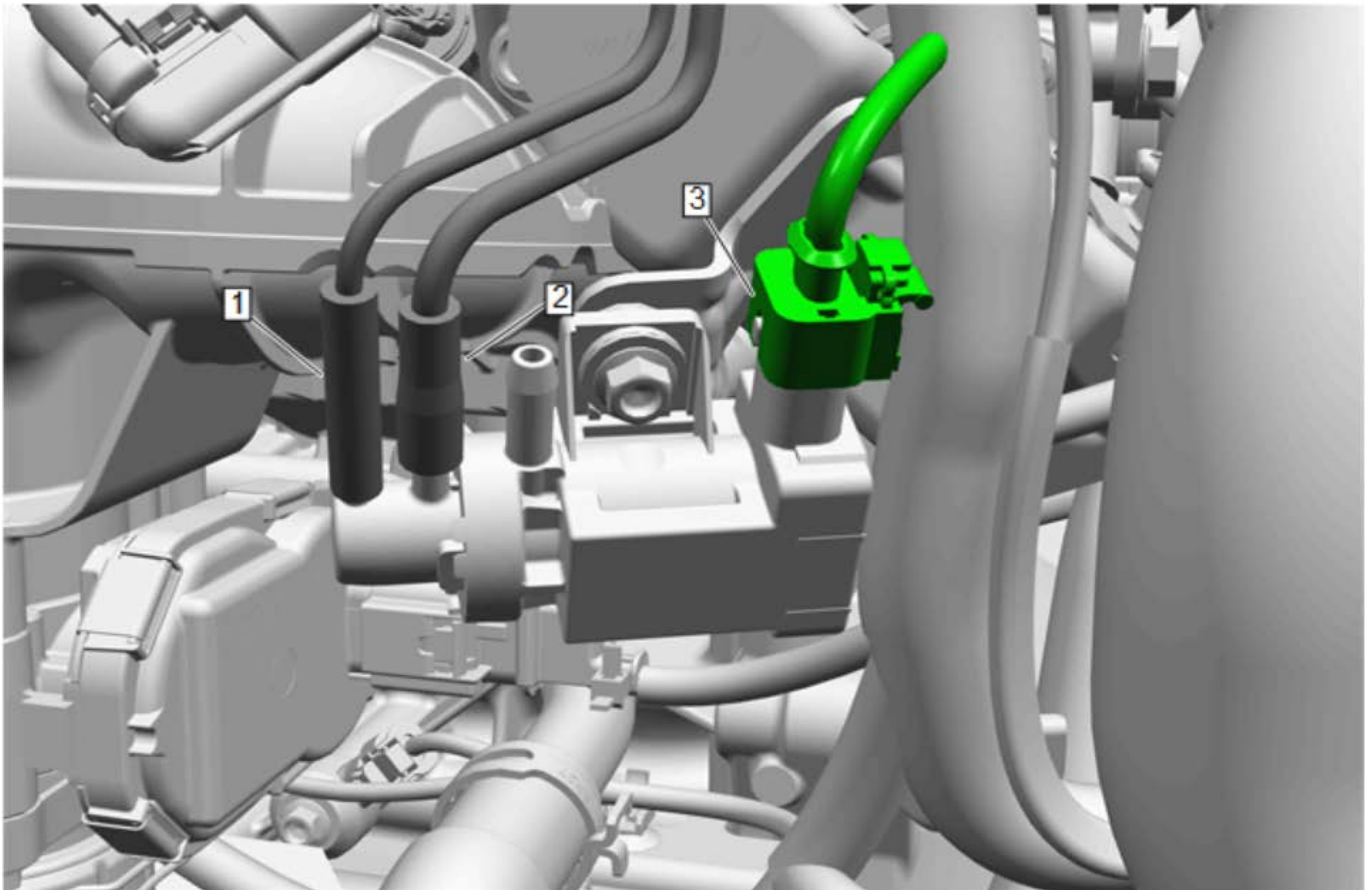
5392518

1. Disconnect the Turbocharger Wastegate Actuator Vacuum Tank Solenoid Valve Tub (2) from the Turbocharger Wastegate Regulator Solenoid Valve.
 2. Connect the EN-23738-A Vacuum Pump to the Turbocharger Wastegate Solenoid Valve Actuator supply port.

3. Engine at operating temperature at idle.
 4. Verify the tool reading: EN-23738-A Vacuum Pump = Less than -17 kPa (-0.17 bar, 5 in Hg).
 - If -17 kPa (-0.17 bar, 5 in Hg) or greater.

- If less than -17 kPa (-0.17 bar, 5 in Hg).
- ⇒ Engine Speed Greater than 5000 RPM — For 2 s.
- ⇒ Verify the tool reading: EN-23738-A Vacuum Pump = Greater than -50 kPa (-0.5 bar, 15 in Hg).

- ⇒ Test or replace the component: Turbocharger Wastegate Regulator Solenoid Valve. Refer to *Turbocharger Wastegate Regulator Solenoid Valve Removal* in the Service Manual and *Turbocharger Wastegate Regulator Solenoid Valve Installation* in the Service Manual.

- If less than -50 kPa (-0.5 bar, 15 in Hg).
- ⇒ Test or replace the component: Turbocharger Wastegate Regulator Solenoid Valve. Refer to *Turbocharger Wastegate Regulator Solenoid Valve*

Removal in the Service Manual and *Turbocharger Wastegate Regulator Solenoid Valve Installation* in the Service Manual.

- If Greater than -50 kPa (-0.5 bar, 15 in Hg). The Turbocharger Wastegate Regulator Solenoid Valve has been validated to be functioning correctly and proceed to Turbocharger Inspection.
