Service Bulletin

Bulletin No.: 23-NA-102

Subject: Drivability Concerns, Hesitation, Transmission Shifting Rough/Harsh, Malfunction Indicator Lamp (MIL) Illuminated - Multiple DTCs Set

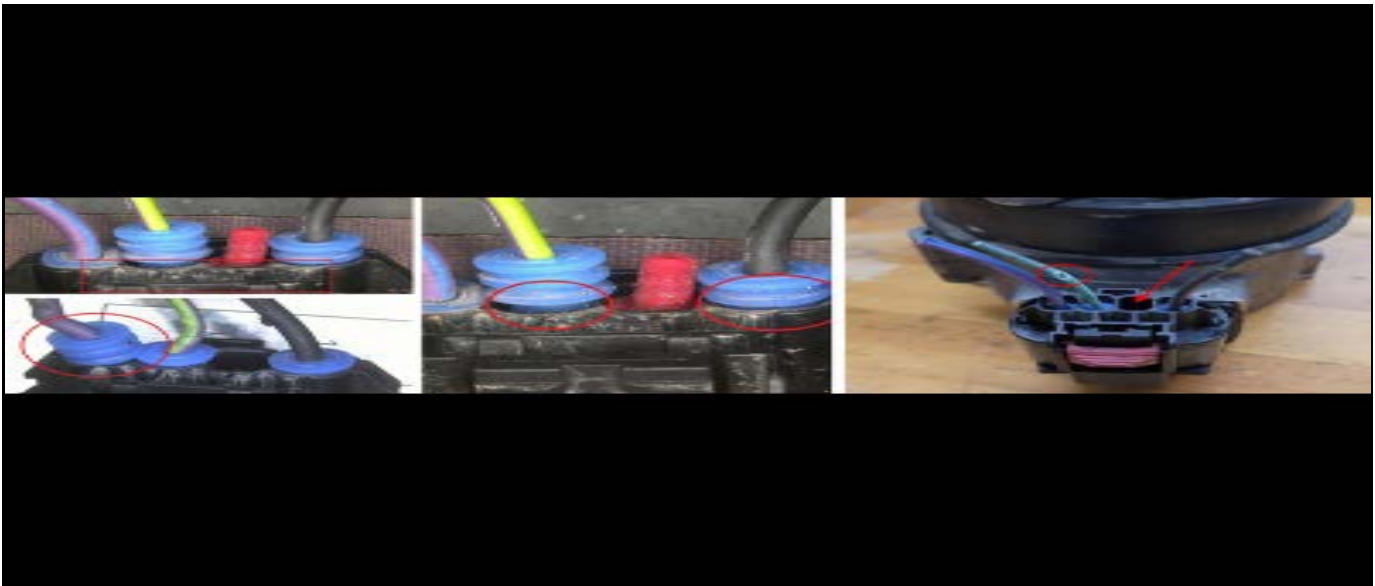
6219342

Area of Concern at the CAC Pump Electrical Connector

An open cavity or an unsealed pump connector allowing water into the (M10) charge air cooler pump electrical connector might be the root cause of the communication failure.

DTCs that may be common with water intrusion the electrical connector:

Note: U02A9 might be set with or without U1345 (LIN BUS1 Failure).

- Check the CAC Pump connector sealing and look for any corrosion at the pump due to water leakage.

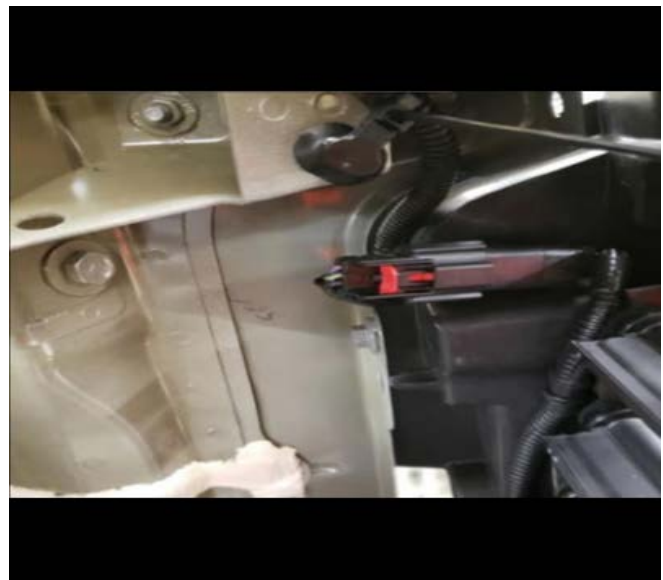
6219339

Area of Concern Active Grille Air Shutter Actuator In-line Connector

The following DTCs may be caused by the engine wiring harness to active grille air shutter actuator in-line connector (X618 on the pickup and X604A On the SUV). Please check circuit 4621 which may be:

- Not properly connected
- Not properly held by the rear clip
- Grounded on the radiator

The graphic above shows how the proper connection must be.

- Check the active grille air shutter actuator in-line connector for not being properly connected or grounded to the radiator.

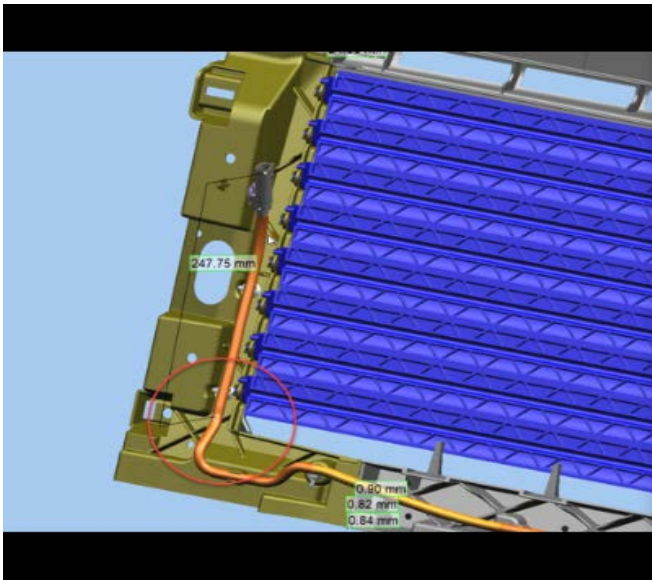
6219340

DTCs may be caused by the active grill air shutter wiring pinched at the radiator support.

The graphic above depicts where a pinching condition may be located.

DTCs that may be common with the wiring harness contacting the radiator or an improper connection:

- Check the active grill air shutter wiring route to identify possible damaged points in the wiring.

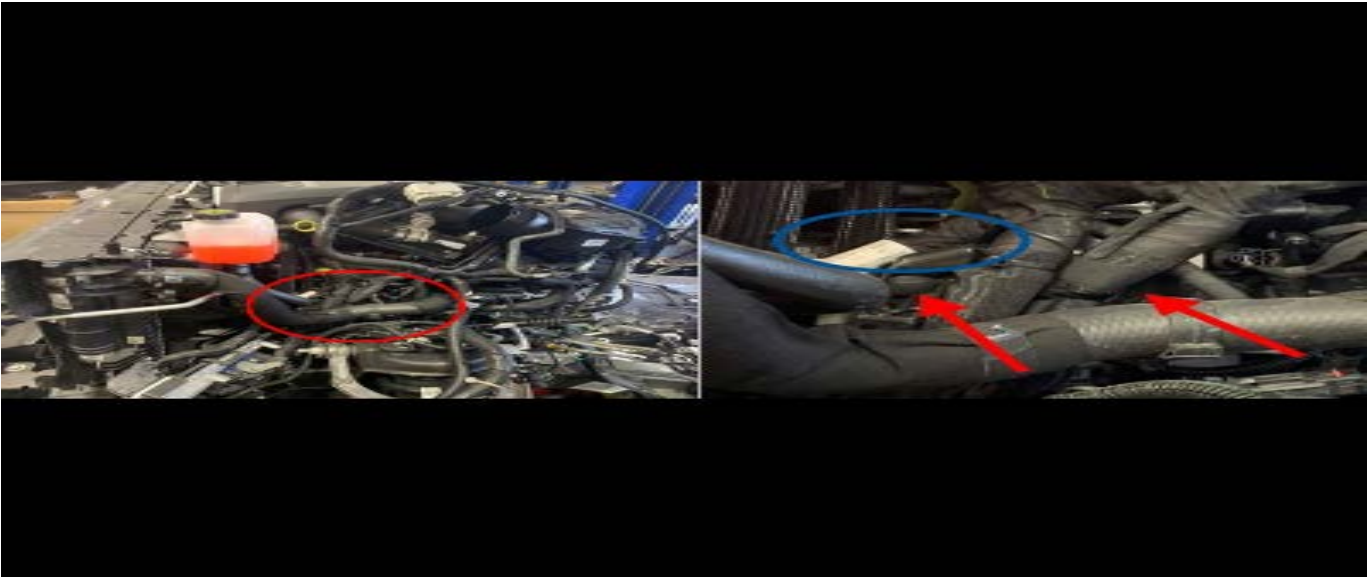
6357536

LM2 Area of Concern at Alternator Bracket

- Arrows indicate location of retainer pins that were not properly installed.
- Blue circle indicates where a chafe in the wiring has occurred. The mis-installed bracket allowed the harness to lay on the alternator.

Note: Using Woven Polyester Electrical Tape (PET), tape all the contact points of the wiring harness ensuring that the tape is applied in a double layer extending along the harness past the splice sleeves. Verify all straps are secured and retainers are installed.

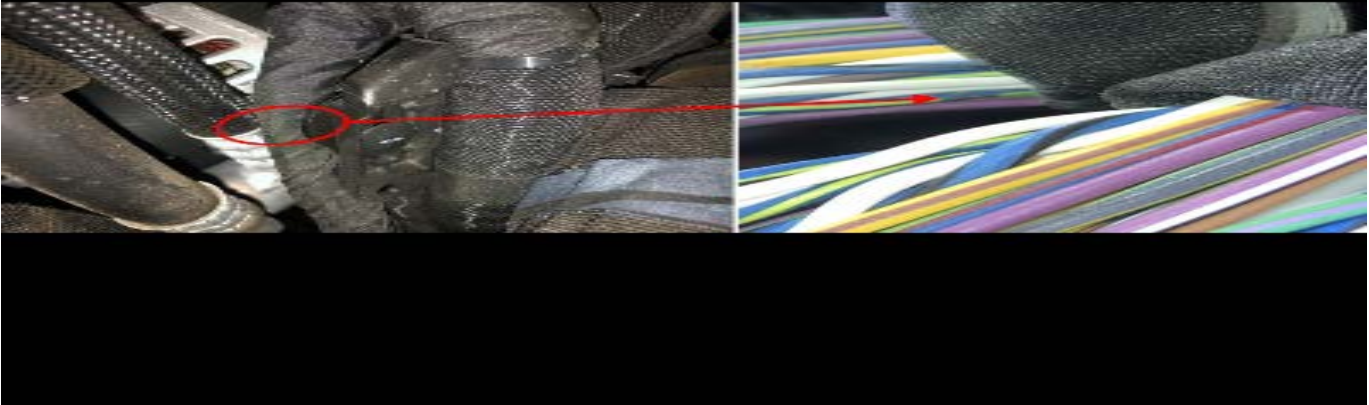
6357567

This is CAN 3 wire harness. Can 4 is also in this bundle only blue and yellow twisted with white.

LZ0 – Wiring Harness Contacting the A/C Line and Alternator Bracket.

For both the LM2 and the LZ0, the DTCs that may be common with the wiring harness contacting the A/C line and alternator bracket:

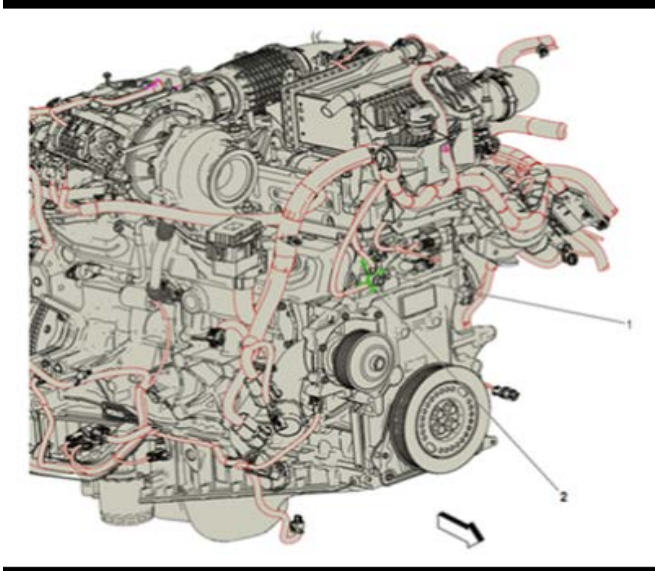
6400093

Loose Ground

Inspect ground connections G176A (1) and G177B (2) may exist. Please check for any:

- Loosen condition
- Damaged or dirty threads

DTCs that may be common with a loose ground:

Cause	<p>This condition may be caused by one or more of the following:</p> <ul style="list-style-type: none"> • CAC pump electrical connector • Active grill shutter electrical connector • Engine wiring harness contacting the alternator bracket • Loose ground at the front of the engine
Correction	Repair the wiring using SI procedures. Refer to <i>Wire to Wire Repair</i> in the Service Manual or <i>Ground Repair</i> in the Service Manual.
