Dealer Service Instructions for:

Customer Satisfaction Notification 16A

Heads-up Display

2022 (WL) Jeep® Grand Cherokee

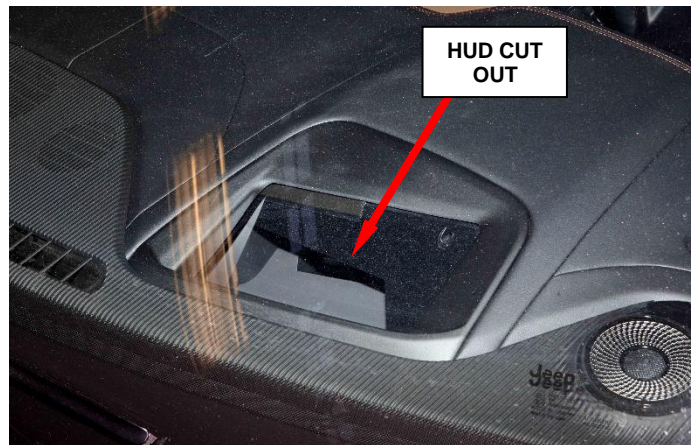
Figure 1 – Instrument Panel Pad

Is there a cut out near the left front speaker as show in figure 1?

YES: No further service required return vehicle to the customer claim inspection LOP.

NO: Proceed to “Service Procedure” step 1.
