## STAR ONLINE PUBLICATION

**Case Number:** S2323000060

**Symptom/Vehicle Issue:** Buzz Squeak Rattle (BSR) From 2<sup>nd</sup> Row Seat.

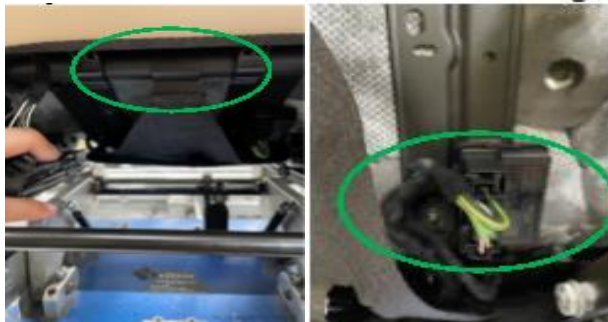
**Customer Complaint/Technician Observation:** Customer notices slight buzz or rattle from the 2nd row seat cushion. Noise could occur on rough roads or bumps.

Examples of properly attached J clip (right) and harness (left)

**Discussion:** With the seat in place and assembled, inspect under the seat for clip and harness location. The seat cover J clip should be centered, and the wire harness should be properly fixed to the seat frame using the harness attached clips.
