STAR ONLINE PUBLICATION

Case Number: S2308000042 Rev.B

Symptom/Vehicle Issue: EPS And Other CAN C Modules Offline, U0001-00, U0002-00, and U0131-00 Can C Bus Diagnostic Trouble Codes (DTCs).

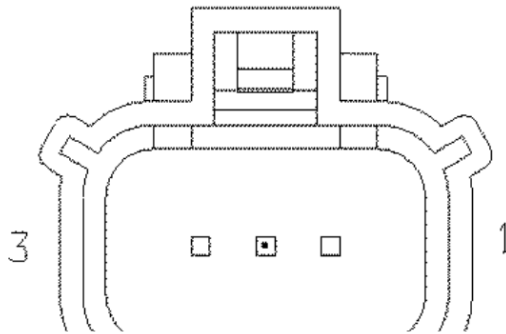
MODULE-EPS C1

End View

Cav	Circuit	Gauge	Color	Function
1	D138	0.35	YE	CAN C (-)
2	D139	0.35	YE/BN	CAN C (+)
3	F942	0.50	PK/VT	FUSED IGNITION SWITCH OUTPUT (RUN-START)

Full Repair Kit: 68358151AA
