STAR ONLINE PUBLICATION

Case Number: S2323000061

Symptom/Vehicle Issue: Water Entering Rear Of Vehicle At Liftgate Striker Area.

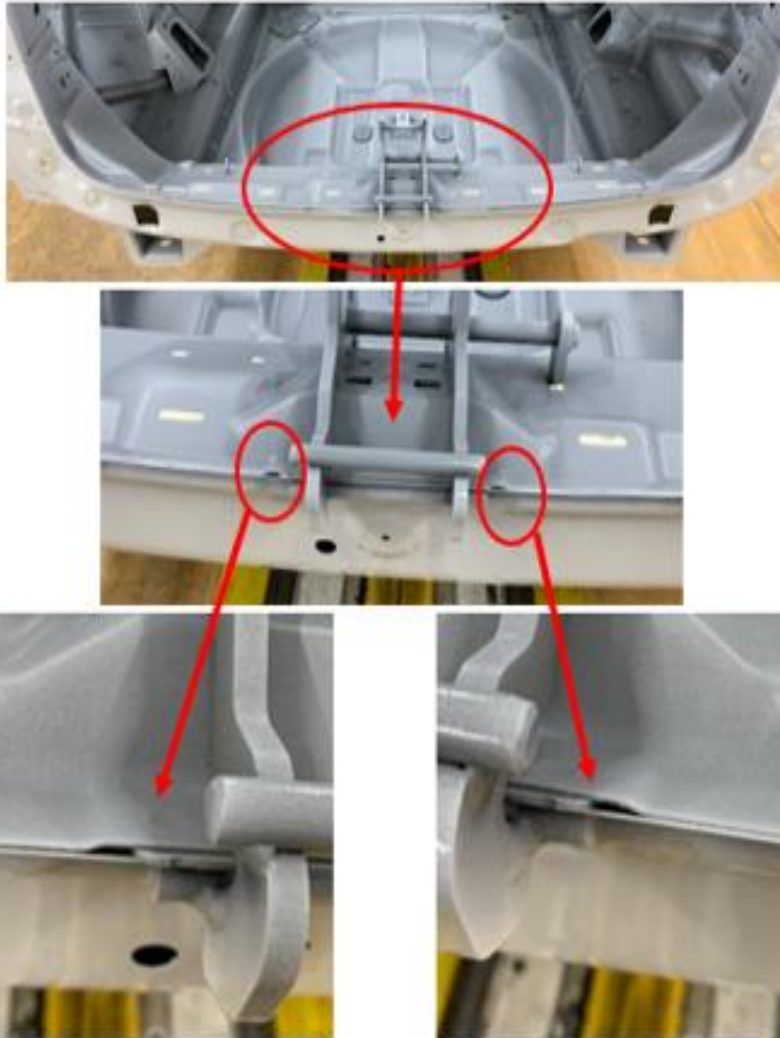
Customer Complaint/Technician Observation: After a car wash, power washing, or a rain/weather event customer may notice water puddling near the liftgate striker.

Fig 1.
Liftgate Opening Sill Area.

Discussion: If there is water found near the striker or in the rear spare tire well area, remove the rear liftgate scuff plate and liftgate weatherstrip. Refer to Service Library 23 - Body / Interior / PLATE, Scuff, Liftgate / Removal and Installation. Using Mopar Butyl Tape 04076274AB, fill the 2 openings shown in Fig 1 to prevent water entry. Install the weatherstrip and liftgate scuff plate. Water test to confirm the repair.
