STAR ONLINE PUBLICATION

Case Number: S2323000063

Release Date: August 2023

Symptom/Vehicle Issue: Outer Tail Lamp Front Edge Has A Gap To The Quarter Panel Or Tail Lamp Appears Loose.

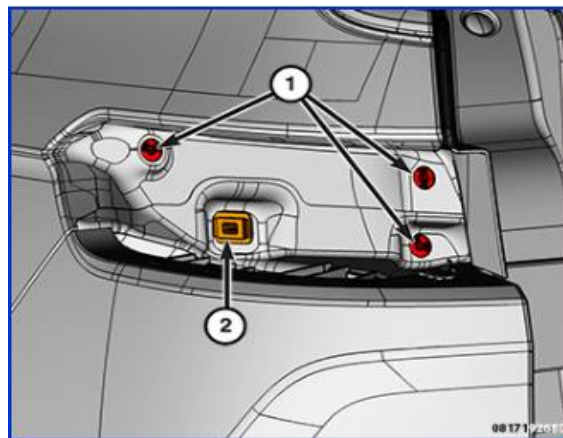
1 - Round Grommets

2 - Rectangular Grommet

Fig 1.
Outer Tail lamp location. Left shown. Right similar.

1. Attempt to remove and reinstall the lamp. Note the round rubber gromets shown in Fig 1 are one time only use and will require replacement. Refer to Service Library 08 - Electrical / 8L - Lamps and Lighting / Lamps/Lighting - Exterior / LAMP, Tail / Removal and Installation.
2. Did removal and installation of the lamp resolve the condition?

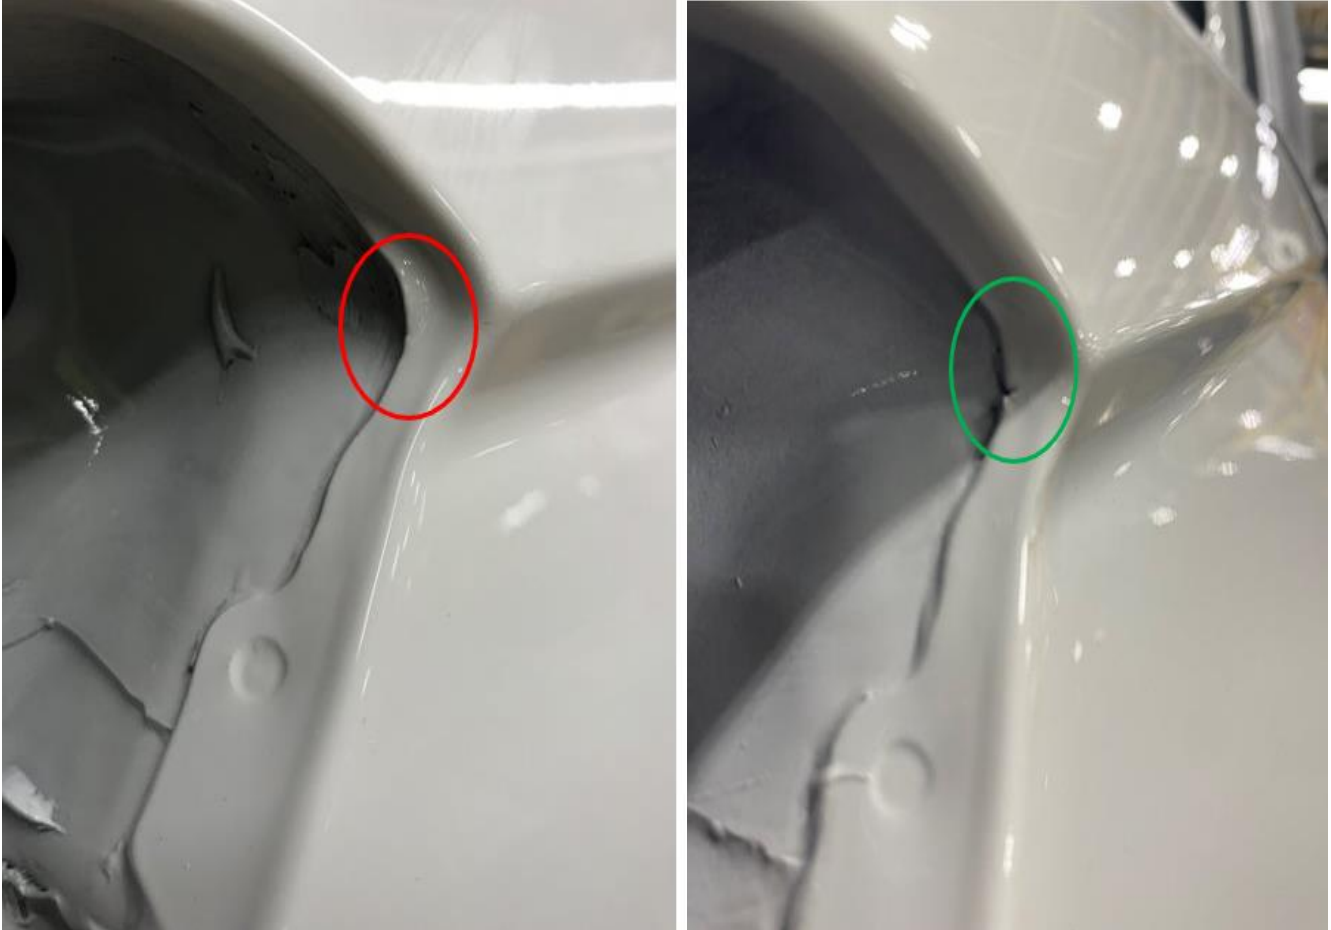
Fig 2.

Customer Complaint/Technician Observation: Technician may find the lamp will not fully seat and snap into position. Front section of the lamp is touching the quarter panel flange. The interference may not allow it to fully seat.

Left image- curled flange preventing tail lamp to fully seat.

Right image – Ideal shape of the flange to allow the lamp to properly mount.

>>>No. Unable to fully seat the lamp or gap is still an issue. Proceed to step 3.
3. Inspect the quarter panel flange at the front of the tail lamp opening. If the lamp has interference to the metal flange the flange will require adjustment. Only follow this procedure if it is impossible to seat the front edge of the tail lamp using other means such as replacing the grommets. You will need to use a body

hammer, non-marring block or dolly, and protective masking tape to protect the finish on the vehicle. Using the body hammer gently adjust the quarter panel flange at the forward edge of the tail lamp pocket in order to allow the lamp to fully seat (Fig 2.). Work slowly and carefully to protect the finish on the lip. If paint damage does occur repair the paint damage using standard refinish methods. Then seat the tail lamp and reassemble.
