STAR ONLINE PUBLICATION

Case Number: S2308000103

Symptom/Vehicle Issue: Service Air Suspension Message Displayed on Cluster

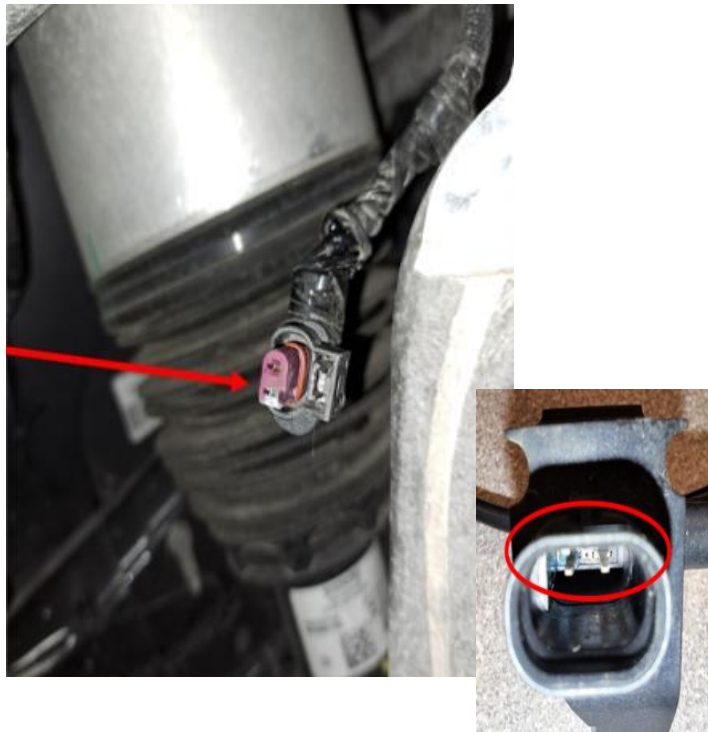
Customer Complaint/Technician Observation: The owner complains of a service air suspension message being displayed on the cluster. The technician observes the Air Suspension Control Module (ASCM) is setting Diagnostic Trouble Code (DTC) **C15D1-15-LEFT FRONT WHEEL ACCELERATION SENSOR-CIRCUIT SHORT TO BATTERY OR OPEN** active or stored.

Repair Procedure: Inspect the left front acceleration sensor connector D2558 for any signs of corrosion, clean and replace the connector as needed. Secure connections using the push-pull-push method and test the operation.

Connector repair kit if needed.
68507961AA
