STAR ONLINE PUBLICATION

Case Number: S2308000100

Symptom/Vehicle Issue: Multiple Warning Lights, Sealer Between Ground Stud G908A And Eyelet

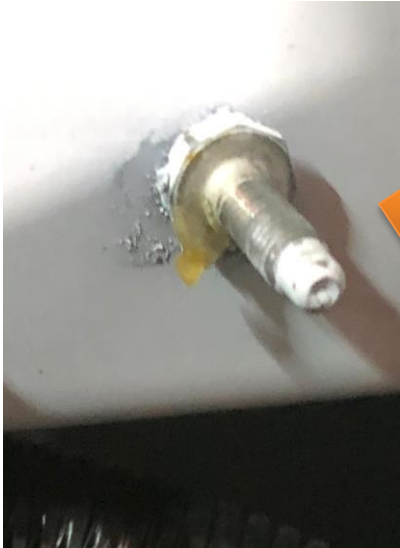
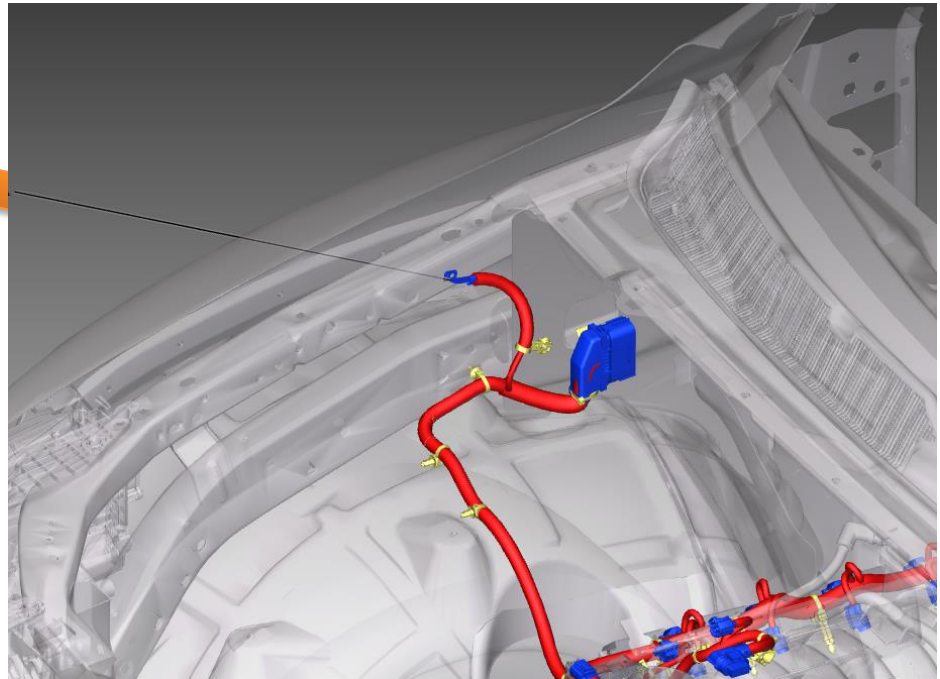
Discussion: The vehicle may have multiple warning lights illuminated in the cluster. Upon scanning the vehicle for DTC's you may find U0402 - Implausible Data Received From TCM. This may be caused by sealer in between the G908A ground stud and eyelet.

Diagnosis: Locate the G908A ground under the hood on the passenger side fender. Inspect for excessive sealer which may inhibit circuit continuity.

Yellow Sealant Shown On G908A Ground Stud Location

Repair: Using a wire brush or similar, remove any excessive sealant from the body ground stud and ground eyelet.

Verification: Verify the DTC's go stored and can be cleared. Confirm the vehicle no longer exhibits any concerns.
