STAR ONLINE PUBLICATION

Case Number: S2323000066

Symptom/Vehicle Issue: Buzz Squeak Rattle (BSR) From Left Rear Cargo Area Near Subwoofer.

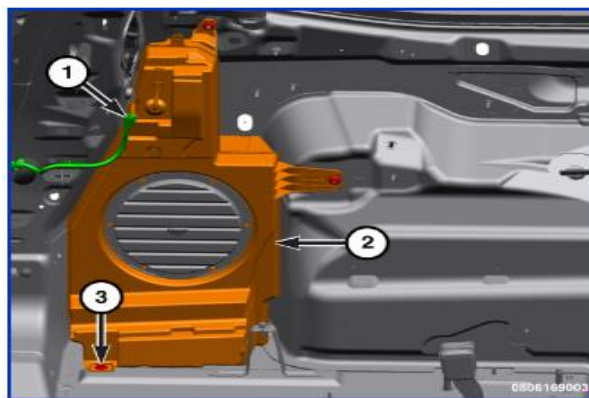
Customer Complaint/Technician Observation: BSR noises over rough roads or with loud music and bass notes coming from inside or outside the rear left cargo area of the vehicle.

1 - Wire Harness Connector

2 - Subwoofer

3 - Subwoofer Fasteners

Discussion: The source of the noise could be related to the subwoofer. Remove the left rear quarter trim panel to inspect the subwoofer installation. Refer to Service Library 08 - Electrical / 8A - Audio/Video/Entertainment/Connectivity / SPEAKER / Removal and Installation Subwoofer. Inspect subwoofer fasteners and harness routing for possible cause of the rattle.
