STAR ONLINE PUBLICATION

Case Number: S2308000105

Symptom/Vehicle Issue: Service Lane Departure and Service Highway Assist Warning Lamps Displayed on Cluster, Adaptive Cruise Control Inoperative

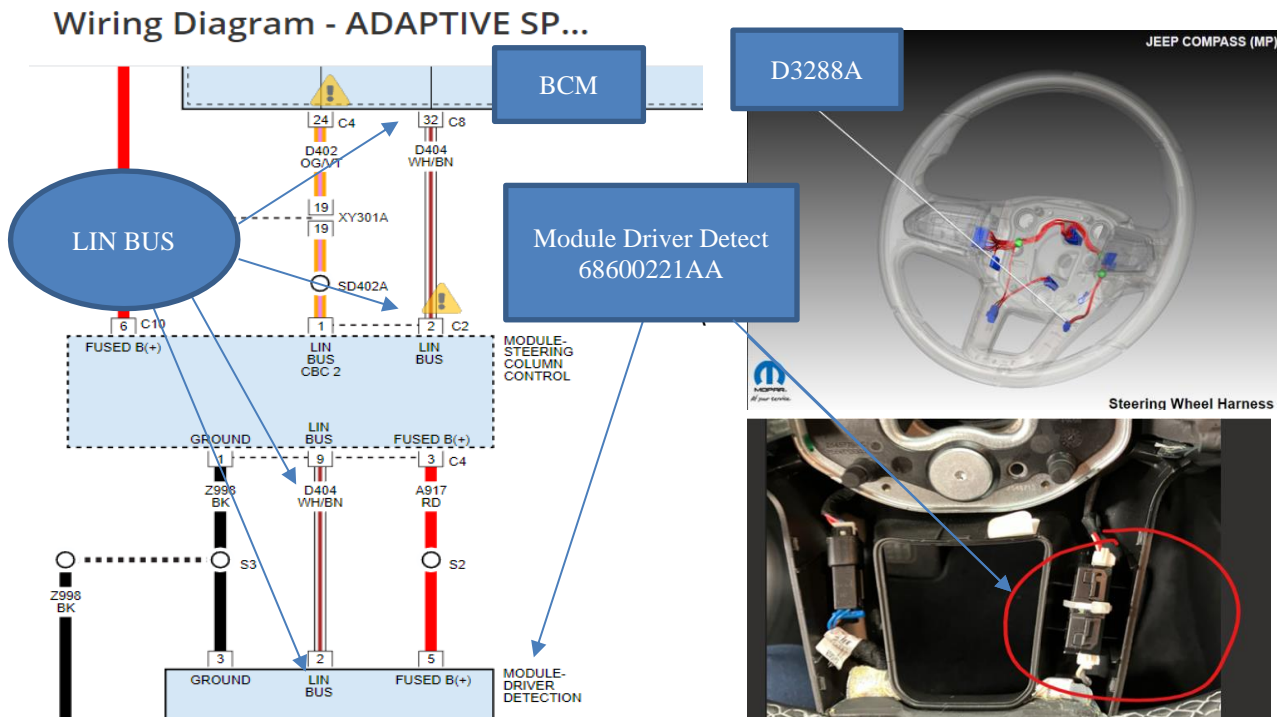
Customer Complaint/Technician Observation: The owner complains about the above systems warning messages. The technician observes the vehicle is setting Diagnostic Trouble Code (DTC) U0140-00 Lost Communication with Body Control Module (BCM) in the Driver Assist System Module (DASM)/Adaptive Cruise Control (ACC).

Repair Procedure: Inspect the steering wheel Hands-on-Detection (HOD) module on vehicles equipped with sales code SJA Highway Assist Systems. Use the push-pull-push method at the D3288A connector to ensure the connections are secure. Verify the involved LIN BUS circuits D404, power and ground are secure with no spread or loose terminals and test the operation to complete.
