STAR ONLINE PUBLICATION

Case Number: S2323000068

Symptom/Vehicle Issue: Water Leak In Cargo Area.

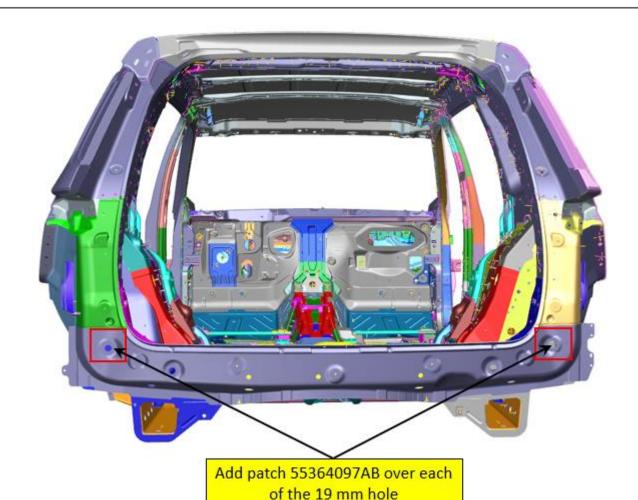
Discussion: Inspect the rear lower D pillar area of the vehicle for possible gaps or holes in foam sealant (Fig 1). Refer to Service Library Service Information 13 - Frame and Bumpers / Bumpers / FASCIA, Rear / Removal and Installation. If any issues are found with the foam sealant, install sealing tape 55634097AB over the area. Use isopropyl alcohol (rubbing alcohol) to remove any dirt oils from the body surface prior to application.
