STAR ONLINE PUBLICATION

Case Number: S2308000032

Symptom/Vehicle Issue: Intermittently The Vehicle exhibits No Crank No Start. Vehicle Goes Into Limp Home Mode. Multiple DTC's And Warning Lights

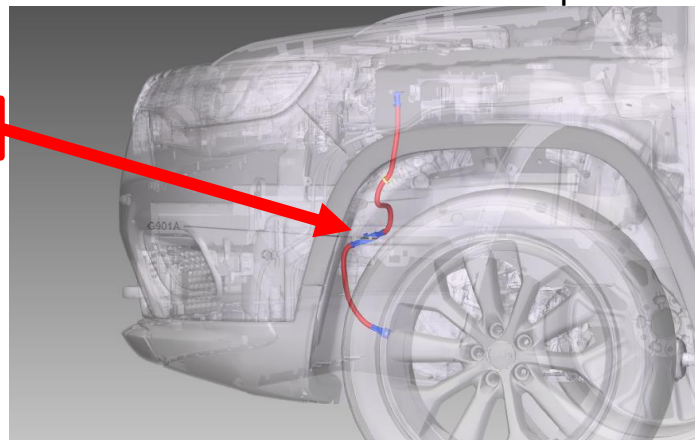
G901A Ground Stud

This may be caused by the main battery ground cable G901A being loose at the frame.

Diagnosis: Remove the drivers side wheel liner and inspect the G901A.

Repair: If the G901 attachment to the frame is loose, tighten the ground to 13 Ft. Lbs.
