## STAR ONLINE PUBLICATION

**Case Number:** S2223000078 Rev.A

**Symptom/Vehicle Issue:** Interior Dust Intrusion In Rear Cargo Area.

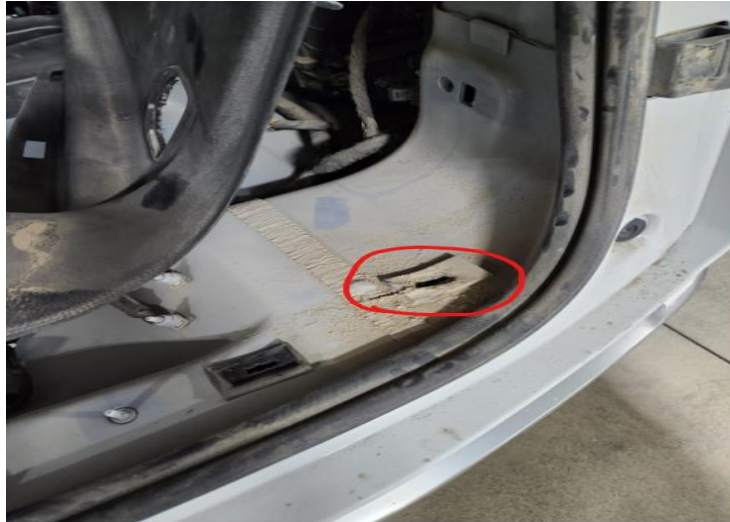
Fig 1

**Customer Complaint/Technician Observation:** Customer may complain of a significant amount of dust in the interior. Highest accumulation may be in the rear of the cargo area when vehicle is driven on dusty roads.

**Discussion:** Examine the liftgate scuff plate and quarter trim outer clip holes for both left and right hand sides (Fig 1). If a large amount of dust is found in this location clean the area and replace the sill trim U clip with a new sealed clip 06513657AA (Fig 2). Panel removal and installation steps can be found in Service Library 23 - Body / Interior / PLATE, Scuff, Liftgate Sill / Removal and Installation and 23 - Body / Interior / PANEL, Quarter Trim / Removal and Installation.

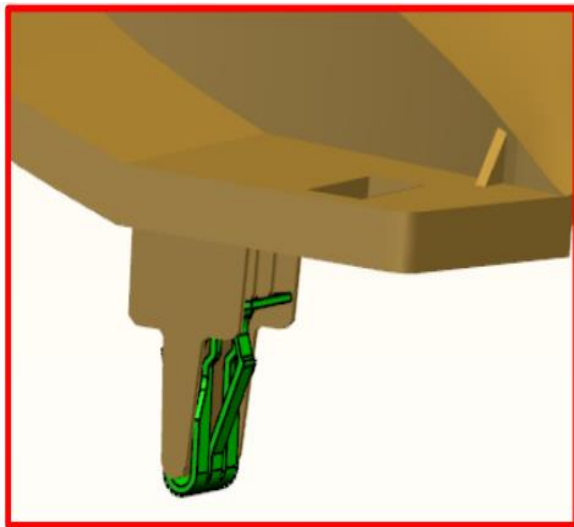
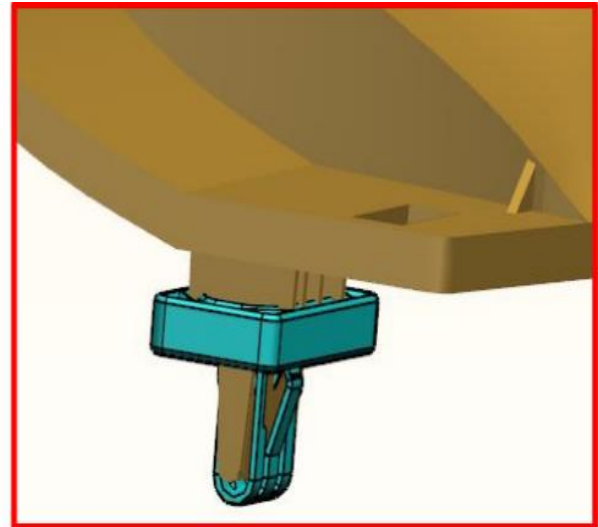
Fig 2.

Original Clip Design

New 06513657AA Clip Design

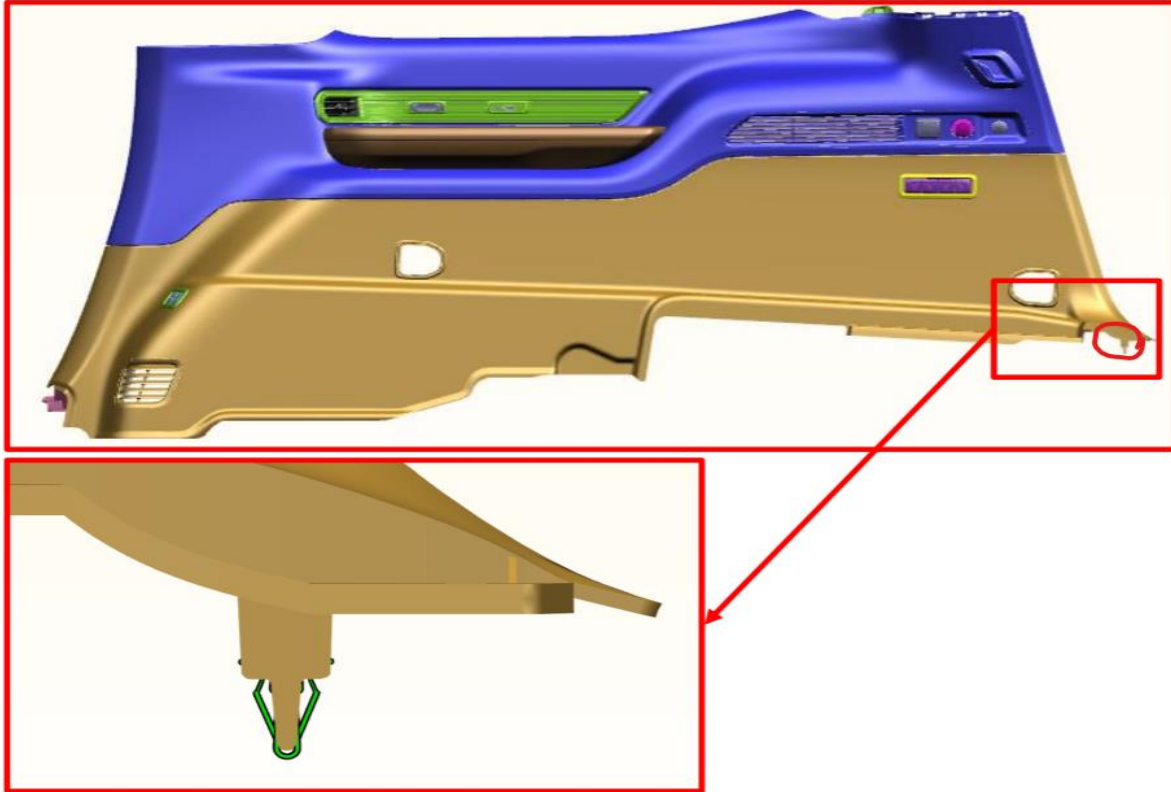
Fig 3

Right Rear Quarter Trim Shown. Left Similar. One Sill Clip Per Side.
