STAR ONLINE PUBLICATION

Case Number: S2008000132 Rev. E

Release Date: August 2023

Symptom/Vehicle Issue: Malfunction Indicator Lamp Illuminated. U11E9 Lost Communication With AGS. Ambient Air Temp Incorrectly Displayed. P0070 And P0073 Set for Ambient Air Temp Sensor

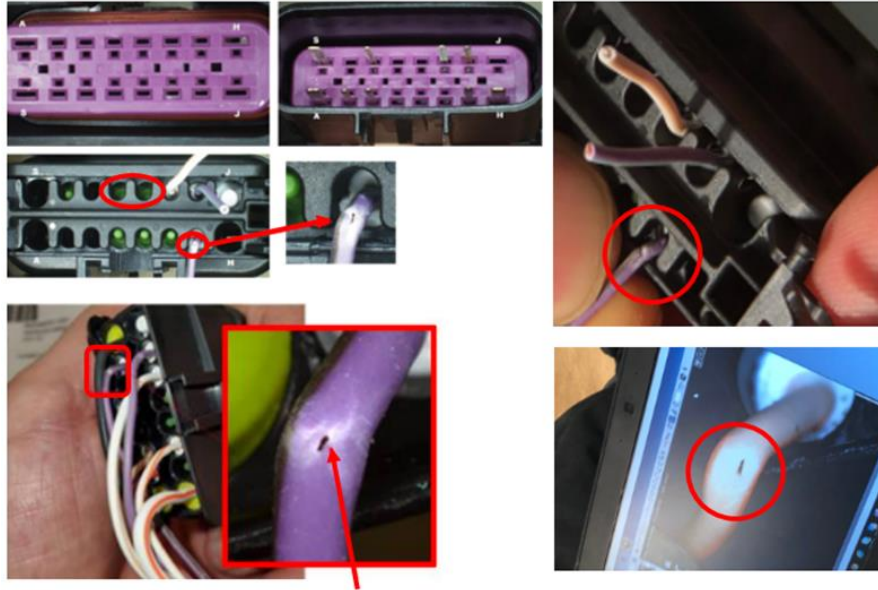
1. Inspect the wiring near the 16-way XY101A Dash to Fascia Connector for nicks and cuts. Disconnect the connector, remove the purple terminal retainer (dash side only), inspect for corrosion and terminal pushout on both sides (fascia/dash).

16-Way XY101A Inline Connector Damage

1. If corrosion, damage, or terminal pushout is present at the XY101A connector. Use connector kit 68497543AB to repair the 16-way Dash side connector and replace the Fascia side harness. A connector repair kit 68500834AA for the fascia side connector is also available. But due to the various possible issues described, fascia harness replacement is recommended.

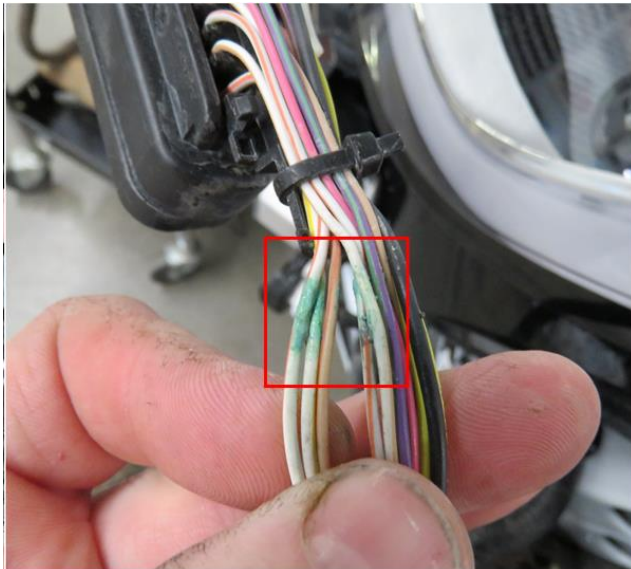
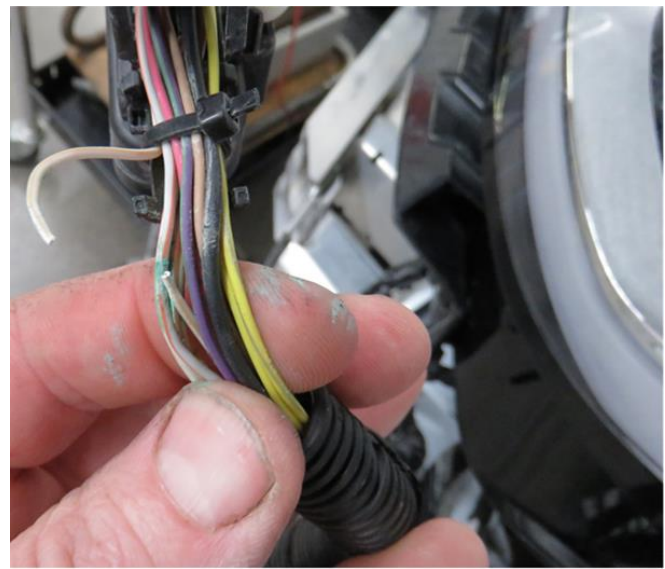
Corroded/Damaged Harness Near 16-Way Connector

If multiple issues are found with either harness. The harnesses should be replaced instead of attempting to repair.

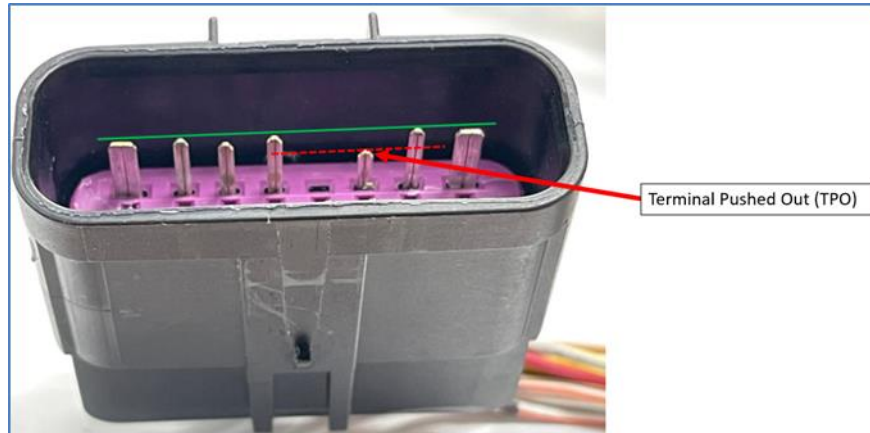
Terminal Pushout on Inline Connector

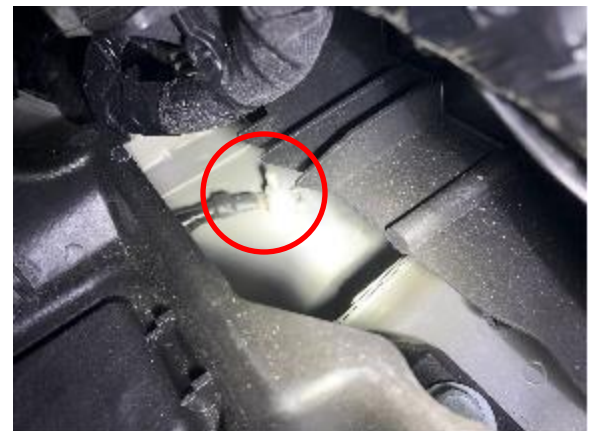
G917 Location

2. The G917 ground located under the battery may be corroded creating high resistance. Water intrusion from the dash side connector could migrate to the ground, gather, and cause corrosion behind the sealed ground eyelet.

2. If the G917 ground is corroded and high resistance is measured. The ground circuit cavity H dash connector should be repaired using kit 68497543AB. Repair the wiring with best practices (use solder, splice Band and heat shrink).
3. If corrosion is present in the AGS connector, replace the AGS. **Do not add dielectric grease to the AGS/fascia connectors.** If corrosion is present in the fascia connector, repair it using connector kit 68396618AB or replace the harness as necessary.
4. If water intrusion is found in either of the Fog or Front Side Marker Lamp housings, replace the Fog and/or Side Marker assemblies. If water intrusion is found in any of the connectors. Use wiring diagrams or Mopar connector repair website to locate the correct connector repair kit (varies by model year).

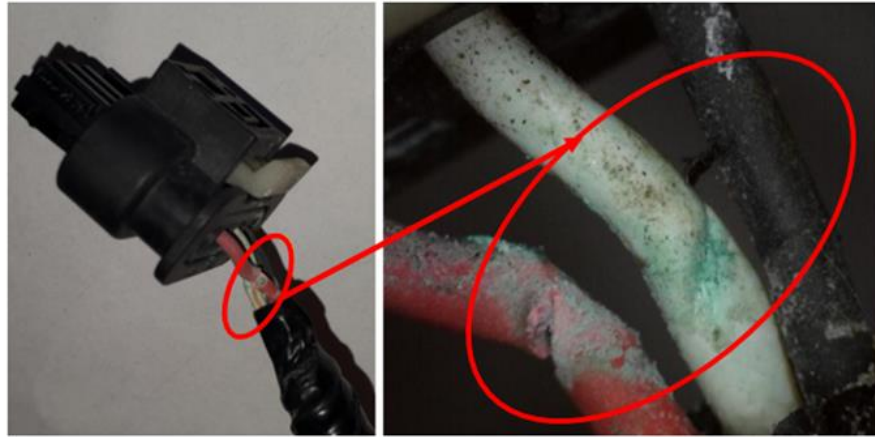
3. Disconnect the AGS to fascia/dash connectors and inspect for damage and corrosion.

Active Grill Shutter Connection Damage/Corrosion

Note: If the corrosion or damage is found on the wiring harness, do not replace the mating connector on the AGS side. Repair wiring and retest. Do not add dielectric grease to the fascia or Dash connectors.
