Case Number: S2308000110

Release Date: August 2023

Symptom/Vehicle Issue: Check Engine Light On, P0113 Intake Air Temperature Sensor 1 Circuit High

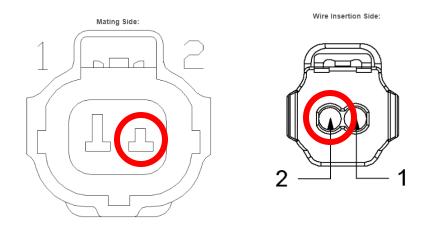
Discussion: The vehicle may come in with a check engine light. Upon scanning for DTC's you may find P0113 Intake Air Temperature Sensor 1 Circuit High in the Powertrain Control Module (PCM). This may be caused by a terminal push out (TPO) or spread terminal of the Intake Air Temperature Sensor (IAT) connector sensor return circuit K915.

Diagnosis: Disconnect the IAT connector (D1586A) and inspect for TPO or a spread terminal at cavity 2 for the sensor return circuit K915

Repair: If a TPO condition is found, reinsert the terminal and confirm it is fully secured using a pull test. If a spread terminal is found or the terminal does not pass the pull test, use repair kit 05014003AA to replace the terminal.
