STAR ONLINE PUBLICATION

Case Number: S2223000075 Rev. A

Symptom/Vehicle Issue: Front Fascia Cover Gaps And Or Poor Fitment Near

Headlight.

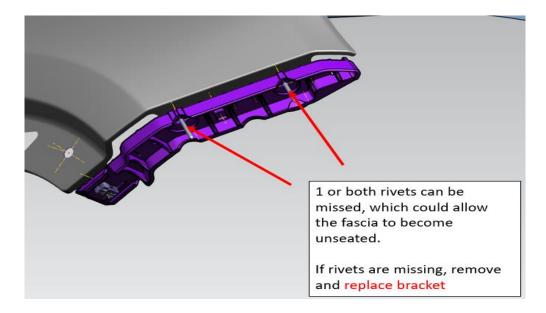
Fig 1. Fascia Retention Bracket And Rivets (Attaches To The Fender).

If the front fascia has a gap at the headlight, remove the front fascia and inspect the body mounted fascia brackets. Refer to Service Library 13 - Frame and Bumpers / Bumpers / FASCIA, Front / Removal and Installation. If one or both rivets are missing, replace the bracket (Fig 1). If the rivets are in place and the bracket is tightly mounted, Inspect the fascia snaps (Fig 2).
