## STAR ONLINE PUBLICATION

**Case Number:** S2108000138 Rev. A

**Symptom/Vehicle Issue:** Steering Column Power Tilt Inoperative

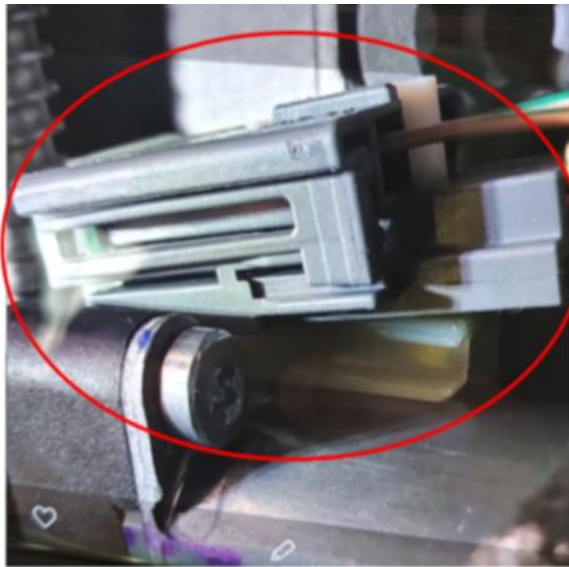
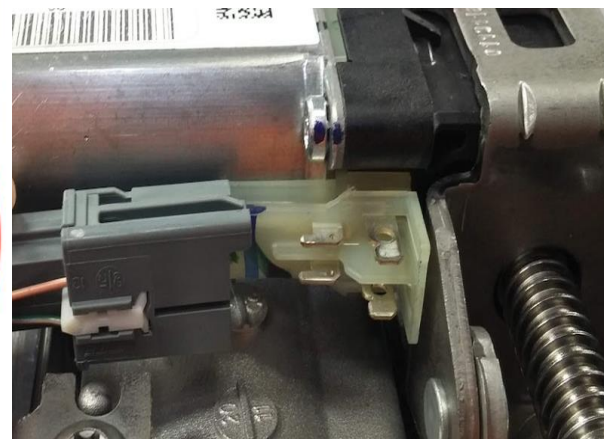
**Fig 1**

**Customer Complaint/Technician Observation:** The owner complains the power tilt steering column does not operate as commanded. The technician observed DTC B1D97 STEERING COLUMN TILT MOTOR CONTROL CIRCUIT PERFORMANCE set in the Module Seat Memory Driver (MSMD).

**NOK**

**Repair Procedure:** Inspect the electric steering column connector D3051A as seen below and in the circuit detail Fig 1, 2. Inspect for any terminals for a spread and or pushed out, terminal. If no signs of terminals spread or pushed-out, use the push, pull, push method to ensure the connector is fully seated and secure, no parts required. Clear any DTCs and test the operation to complete.

**Repair Kit Part Number:** 68500078AA  
**Cavity Count:** 4

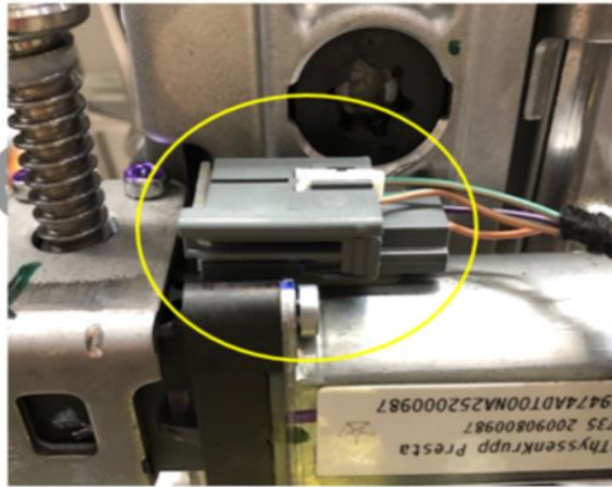
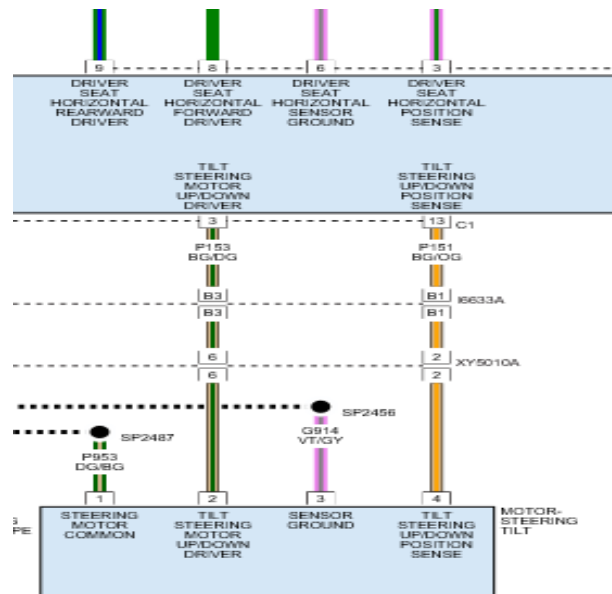
Fig 2

Desired

OK

## Secure connections no parts required.
